# Building Condition Assessments

## Individual School Buildings

This is the Buildings Condition Assessments (BCA) by buildings from the 2022 Final Report by SÄZÄN Environmental Consulting, which includes Facilities Condition Assessment, Learning Environment Assessment, and Accessibility Evaluation completed in 2021.

### III. Individual Assessment Reports

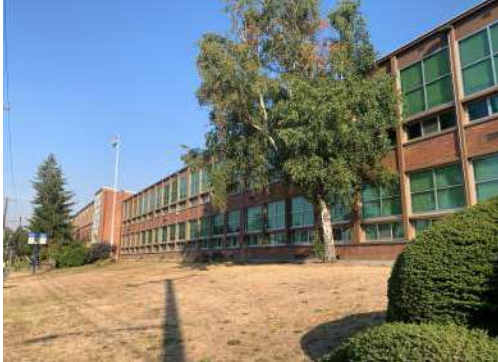
**Aki Kurose**  
3928 S GRAHAM ST SEATTLE, WA 98118

<b>BCA Executive Summary</b>	
<p>CSA - Older middle school from the early 1950s. The site immediately around the school is in fair to poor condition with broken/cracked/spalling pavement at walkways, exterior stairs, and site walls. School exterior shows some signs of cracking/deterioration at masonry, foundations and concrete sills. There has been a clear failure (water intrusion) at the window wall in the library. Some exterior windows have been replaced in teaching areas but a large percentage of original windows still exist. Interior finishes, fixtures, and hardware are poor to unacceptable do to major wear and tear and ADA compliance.</p>	
<p>MEP - Steam boilers provide heat to steam coils in air handlers, unit ventilators, and cast iron radiators through-out the school. The lighting is mostly fluorescent tube T-8. Fire alarm and security systems appear to be working condition. The electrical distribution panelboards are outdated and are fuse style boxes. This is an older school with condition of MEP systems generally ranging from fair to poor.</p>

<b>Site Perimeter Score</b>	4 - Poor: many uncontrolled entries or ineffective perimeter fencing
<b>Recommend Further Egress Analysis</b>	No
<b>Emergency Lighting Throughout</b>	No 'stand-alone' lighting fixtures were observed but emergency lighting could be located on a different circuit or have battery backup ballasts.
<b>Does the means of egress appear deficient?</b>	
Inadequate ADA hardware at exits at grade, poor floor/door clearances and lack of elevator access without aid.

<b>Facility Need - CSA</b>	Total Replacement
<b>Facility Need - MEP</b>	Major Modification
<b>Facility Needs - LEA</b>	Total Replacement

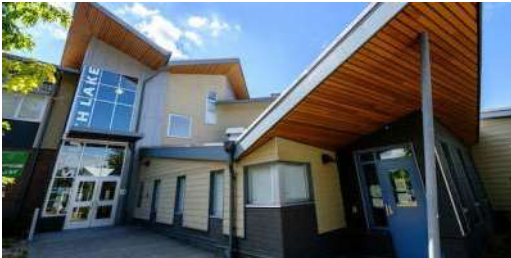
**Alan T. Sugiyama**  
8601 Rainier Ave S SEATTLE, WA 98118

CSA - The facility is in good condition and being well maintained. Interior finishes are holding up well. No major issues. Roofing is in good condition but needs routine moss cleaning. There are exterior wood and metal soffit materials that are showing a coating finish failure and peeling.

<b>Site Perimeter Score</b>	4 - Poor: many uncontrolled entries or ineffective perimeter fencing
<b>Recommend Further Egress Analysis</b>	No
<b>Emergency Lighting Throughout</b>	Yes
<b>Does the means of egress appear deficient?</b>	
No

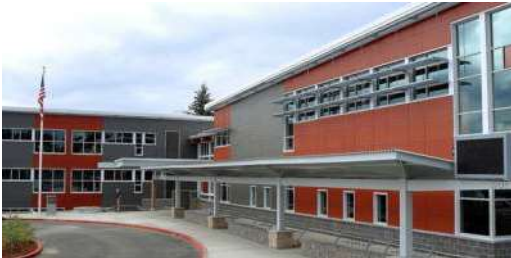
**Arbor Heights**  
3701 SW 104th St SEATTLE, WA 98146

CSA - Arbor Heights is a 4 year old school that looks to be in great shape. The biggest maintenance issue with the school is the landscaping, which is not being maintained. Some minor repairs to the siding were observed on the south façade.

MEP - The primary HVAC system is a two pipe fan coil system. The Principal explained there have been some ventilation issues in the administrative area. Electrical distribution system is standard 480 volt three phase and 208 volt step down transformer. The lighting is in like new condition and LED. Access controls security fire alarm fire sprinkler system are all in like new condition.

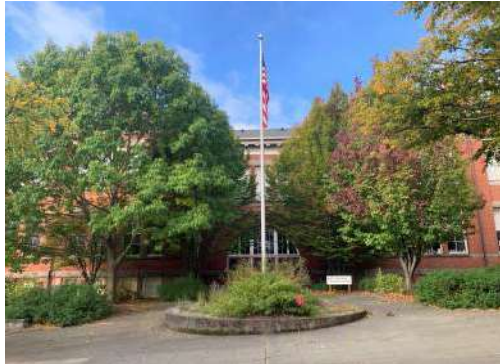
**B. F. Day**  
3921 LINDEN AV N SEATTLE, WA 98103

CSA - While B.F. Day ES is an older facility, the basic structure of the building is sound. Exterior masonry and roofing are in good condition, with the exception of the metal soffit/facia paint, which is flaking off. Windows need replacement for energy efficiency, safety, and to provide operable windows for outside air. Some insulation upgrades were made during the 2017 seismic upgrade, and the attic at the floor level has been insulated. However there are exterior wall areas that have not been upgraded. Some interior finishes were upgraded in 2006/2008, while others sorely need upgrading, most notably flooring. The existing gym floor is unacceptable. Most ADA upgrades have been completed. Hard and soft play areas are in reasonably good condition. Due to the historic nature of the building, investment in a major modification is appropriate.

CSA - B.F. Day's former Power Plant building is leased to the Fremont Arts Council. The building is a concrete structure with brick veneer. The concrete roof structure shows signs of past water intrusion and spalling. The walls, where visible, show some water staining. The exposed concrete structure shows signs of weathering. No visual evidence of any seismic upgrade of this building was observed. The brick veneer at the building and chimney stack has spalled brick in locations and shows some signs of water staining and efflorescence. Brick exterior walls require tuck pointing. The windows are wood, single pane and are in in fair condition, as are the wood doors. The roofing is in fair condition, though there may be leaks as evidenced from the water staining on the concrete roof structure. The flashing is in fair condition. The interior finishes are in poor condition. Given the lease use, preventative maintenance is what is appropriate. Use by the District as program area, would require major modification.

MEP - B.F. Day ES's Main Building HVAC system consists of older 1990s water-source heat pump units with newer DDC system upgraded in 2000's. The condensing loop is tempered by an older boiler and 1990's cooling tower. Both still operate, but are at the end of their useful life. There have been some electrical upgrades in the past, but is now reaching max capacity with advances in newer technology programs. All domestic hot water heaters are old and the District should plan for replacement in the near future. Interior lighting is in fair condition with a mixture of T-8 and older fluorescent lighting, while exterior lighting is showing wear and tear over the years of use with dark spots and non working fixtures.

In the Leased Building (Fremont Arts Council), the HVAC system consists of a single gas pack furnace and radiant heaters hanging throughout open space. The electrical systems are very old and missing coverage in several areas. Interior and exterior lighting is severely limited, even at the entrance. The building lack any fire sprinkler system and the domestic hot water heater and sinks are at the end of their useful life.

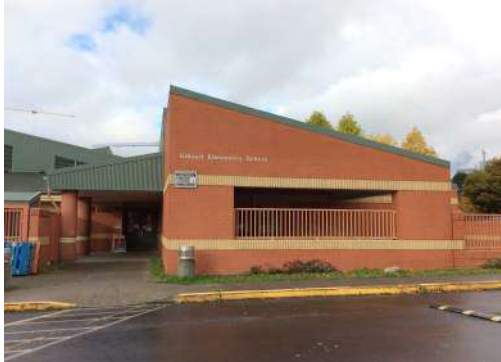
**Bailey Gatzert**  
1301 E YESLER WY SEATTLE, WA 98122

<b>BCA Executive Summary</b>	
<p>CSA - Bailey Gatzert ES is worn and showing its age, with most interior finishes, doors and windows rated in fair condition. The exterior envelope does not appear to be insulated, or at best under-insulated. The brick veneer is in good condition, as is the roof framing and likely the wall framing. There is no record of the structure having any seismic upgrades. The floor slab shows signs of cracking in several locations. The building is not fully ADA-compliant. The interior vision-lites and relites are wire glass.</p>	
<p>MEP - The HVAC system is a distributed heat pump system with cooling tower and boilers serving the condenser water system. The system appears to be 30+ years old and the cooling tower and boilers are old. The entire electrical distribution is also 30+ years old and due for major upgrades. The fire alarm is non-addressable and is also due for major upgrades.</p>

<b>Site Perimeter Score</b>	3 - Fair: some uncontrolled entries
<b>Recommend Further Egress Analysis</b>	Yes
<b>Emergency Lighting Throughout</b>	Yes
<b>Does the means of egress appear deficient?</b>	
Primary issue is some of the restrooms being non-ADA compliant.

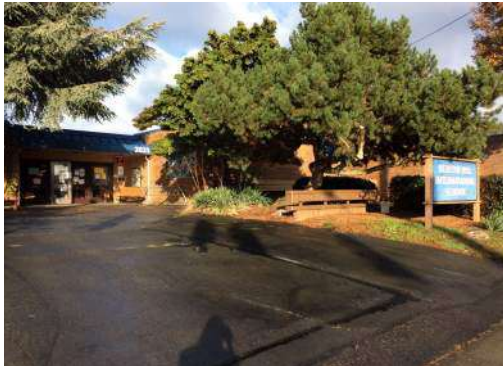
**Beacon Hill International**  
2025 14 AV S SEATTLE, WA 98144

CSA - Beacon Hill ES' new wing addition is in good condition. The older building, however, has issues including old leaks. Note that staff reported that mold may exist in areas of wall leaks, but this could not be verified by this assessment. The building is not fully ADA-compliant, lacking latch lever and panic bar hardware in most of the older building. There are also some non-compliant toilet stalls and several half-height toilet partitions in the older student classroom pods and the gym. Older building thermal envelope is inadequate with single pane aluminum frame windows and walls with insufficient or non-existent insulation. Roof insulation also appears to be inadequate. Some cracking of the slab was evident. While the carpet is in good condition, the VCT / VAT flooring needs replacement, as does the gym's composite sports flooring.

MEP - Beacon Hill ES' HVAC system generally consists of a gas fired, multi zone air handling system for the classroom pods. The newer 2005 building HVAC system is also a gas fired system, but configured as a single zone air handling system, as is the gymnasium. The lighting is generally inefficient with T8 fixtures. All other systems seem to be functional and operational. The site lighting is in need of repair of broken fixtures. Based upon the assessment of MEP systems, the building should be considered for replacement within the next 5 to 10 years.

<b>Site Perimeter Score</b>	3 - Fair: some uncontrolled entries
<b>Recommend Further Egress Analysis</b>	Yes
<b>Emergency Lighting Throughout</b>	Some missing and/or non-illuminated at the gym.
<b>Does the means of egress appear deficient?</b>	
Yes, primarily due to lack of ADA-compliant hardware.

<b>Facility Need - CSA</b>	Major Modification
<b>Facility Need - MEP</b>	Total Replacement
<b>Facility Needs - LEA</b>	Major Modification

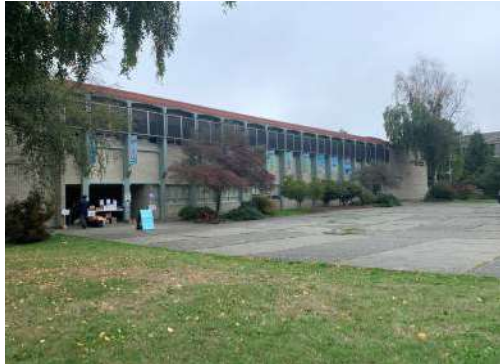
**Broadview-Thomson**  
13052 GREENWOOD AV N SEATTLE, WA 98133

CSA - Building is old. Exterior envelope has insufficient thermal insulation, as well as windows being predominately single pane in non-thermally broken aluminum frames. Concrete structure includes numerous points of thermal bridging. Most exterior doors are not ADA compliant; interior old knob latch sets are in process of being replaced with ADA-compliant lever sets. Acoustics in building are poor due to the extent of hard surfaces (floors, CMU walls, and exposed concrete wall and roof structure. Surface adhered acoustical tiles are falling off in numerous locations. Interior glazing is predominately wire glass.

Gym locker rooms are not in use, other than for storage, in poor condition and not maintained.

Multipurpose room area used as a community/childcare center is in poor condition and lacks adequate facilities, ADA-compliance, seismically reinforced structure, and thermal envelope.

MEP - Hydronic heating consists of under building supply air tunnels delivering air to classrooms via heating coils. Main corridors and common spaces heated by cabinet unit heaters and radiators. Heated water is fed by fairly new Fulton Vantage hydronic boilers in good condition. Domestic hot water for kitchen was replaced in 2016, however shows signs of leaking. Remaining hot water feeds the main building and was recently replaced with high efficiency type unit in 2017. Some upgrades on lighting and electrical are evident, however, most of the electrical and lighting needs to be upgraded. No fire suppression system installed; only older alarm notification bells and horns.

<b>Facility Need - CSA</b>	Total Replacement
<b>Facility Need - MEP</b>	Major Modification
<b>Facility Needs - LEA</b>	Total Replacement
