# Building Condition Assessments

## Individual School Buildings

This is the Buildings Condition Assessments (BCA) by buildings from the 2022 Final Report by SÄZÄN Environmental Consulting, which includes Facilities Condition Assessment, Learning Environment Assessment, and Accessibility Evaluation completed in 2021.

### III. Individual Assessment Reports

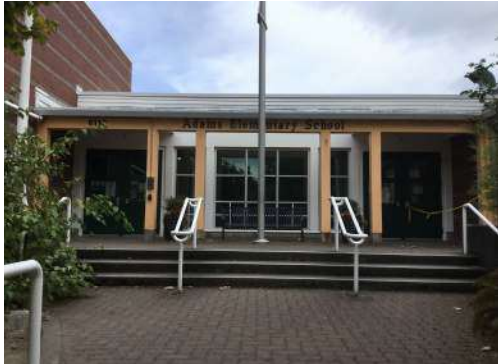
**Adams**  
6110 28 AV NW SEATTLE, WA 98107

CSA - Adams ES is a single story elementary school with a basement. Overall, it is in fair condition. The building envelope needs attention: several areas on the roof are ponding; several window panes seals have failed.

MEP - The heating system is a water source heat pump system with heating only. The HVAC system has newer heat pumps units located in attic spaces and mechanical mezzanines with a single electric boiler with two condenser water pumps. On the roof are two exposed air handling units in poor shape as well as an indoor air handling unit in fair condition serving the gym. The electrical system is in fair condition and the electrical breakers require arc flash labeling. Fire protection systems is in fair condition with a sprinkler system currently being installed throughout the building.

<b>Site Perimeter Score</b>	3 - Fair: some uncontrolled entries
<b>Recommend Further Egress Analysis</b>	Yes
<b>Emergency Lighting Throughout</b>	Yes
<b>Does the means of egress appear deficient?</b>	
Yes, many of the egress routes have exterior stairs.

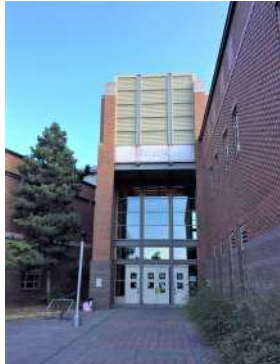
**Ballard**  
1418 NW 65 ST SEATTLE, WA 98117

CSA - Ballard High School is in generally good shape for a heavily used, 20 year old high school. Major deficiencies include: failing VCT flooring in major public and circulation areas; exterior doors and hardware are severely worn and need replacement/repair; ADA automatic door openers and push buttons need to be installed at primary lobby entrances, gym and commons; interior wire glass should be replaced with safety glazing; wall finishes are due for a refresh; the building envelope needs attention, particularly to address a leak at the commons clerestory/canopy area.

MEP - Ballard High School has a water cooled heat pump system. The HVAC system appears to have been upgraded in 1999. The outside air ventilation in many cases uses the mechanical rooms as mixing plenums. The setup does not appear to adequately address the ventilation requirements of the school. The electrical service appears to be in good condition. The lighting appears to have some poorly lit spaces throughout the school. General lighting is fluorescent tube lighting with some compact fluorescent fixtures. The data telecom systems appear to be in working order and in good condition. The kitchen equipment appears to be in working order. The dishwasher is leaking from the drain line.

<b>Site Perimeter Score</b>	2 - Good: not fully enclosed but with controlled entries
<b>Recommend Further Egress Analysis</b>	Yes
<b>Emergency Lighting Throughout</b>	Yes

As noted, lack of automatic door openers placing reliance of someone with a disability on help from someone else.

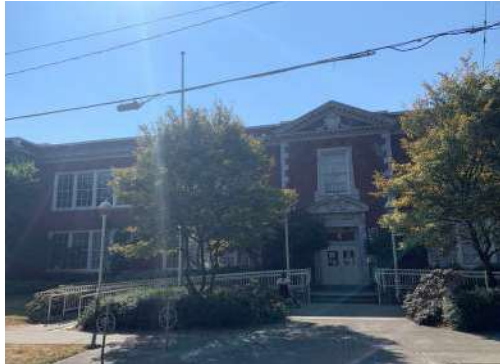
**Bryant**  
3311 NE 60 ST SEATTLE, WA 98115

<b>Site Perimeter Score</b>	1 - Excellent: fully secured perimeter
<b>Recommend Further Egress Analysis</b>	No
<b>Emergency Lighting Throughout</b>	Yes
<b>Does the means of egress appear deficient?</b>	No

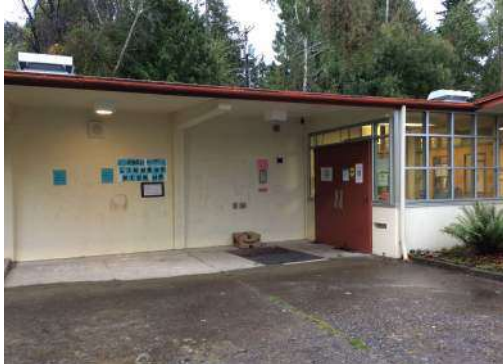
**Cedar Park**  
3737 NE 135th St SEATTLE, WA 98125

<b>Site Perimeter Score</b>	2 - Good: not fully enclosed but with controlled entries
<b>Recommend Further Egress Analysis</b>	No
<b>Emergency Lighting Throughout</b>	Yes
<b>Does the means of egress appear deficient?</b>	
No, other than the threshold lips.

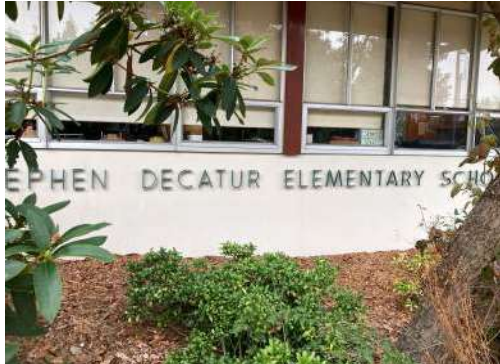
**Decatur**  
7712 40th Ave NE SEATTLE, WA 98115

<b>Site Perimeter Score</b>	1 - Excellent: fully secured perimeter
<b>Recommend Further Egress Analysis</b>	No
<b>Emergency Lighting Throughout</b>	Yes
<b>Does the means of egress appear deficient?</b>	
There is a very steep ramp at the north exit doors.

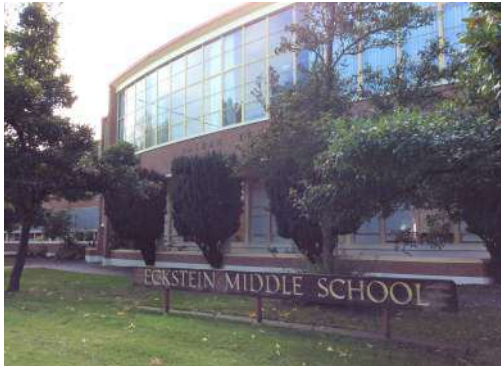
**Eckstein**  
3003 NE 75 ST SEATTLE, WA 98115

<b>Site Perimeter Score</b>	4 - Poor: many uncontrolled entries or ineffective perimeter fencing
<b>Recommend Further Egress Analysis</b>	Yes
<b>Emergency Lighting Throughout</b>	Exit lighting missing: a couple exits in the auditorium which lacked illuminated exit signs, no exit signs from the locker rooms, and 2 of 3 of the exit signs to exterior are not illuminated (lamps out?)
<b>Does the means of egress appear deficient?</b>	
Yes: limited on-grade access, long distance from bus and parent drop-off/pick-up zones to accessible entrances, and lack of activated doors or call-box and electronic lock.

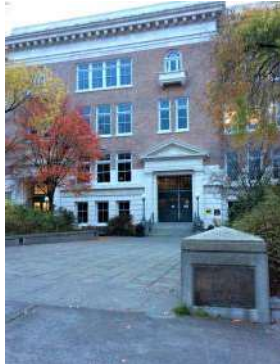
**Franklin**  
3013 S MT BAKER BV SEATTLE, WA 98144

**Does the means of egress appear deficient?**  
Reasonable access to the playfield is not available. Access from street ADA stalls to sidewalk at the gym is unreasonable.

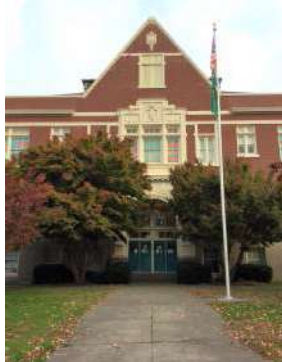
**Gatewood**  
4320 SW MYRTLE ST SEATTLE, WA 98136

<b>Site Perimeter Score</b>	4 - Poor: many uncontrolled entries or ineffective perimeter fencing
<b>Recommend Further Egress Analysis</b>	No
<b>Emergency Lighting Throughout</b>	Yes
<b>Does the means of egress appear deficient?</b>	
Yes, need to install either activated entry doors with pushbuttons or provide a call box.

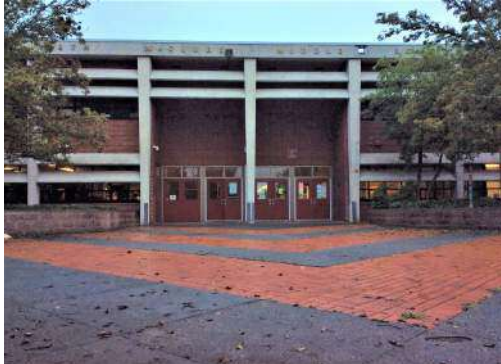
**McClure**  
1915 1 AV W SEATTLE, WA 98119

<b>BCA Executive Summary</b>	
CSA - The school is long past its useful life, is in poor condition, aesthetics are significantly degraded, and the cost to maintain the school warrants replacement of the facility.	
MEP - The mechanical system is generally unit ventilators with steam heat. The larger spaces are served by fan coils units with steam heat. Old boilers provide steam to the building. The domestic water piping is mostly installed as surface mounted and is susceptible to damage. The hand washing stations and kitchen take a very long time to get hot water. The electrical distribution is poor and has a lot of surface mounted conduit. The office and library have floor mounted receptacles that do not work for the room layout and are tripping and shock hazards. Overall, most systems are past their useful life and the facility requires replacement.

<b>Site Perimeter Score</b>	4 - Poor: many uncontrolled entries or ineffective perimeter fencing
<b>Recommend Further Egress Analysis</b>	Yes
<b>Emergency Lighting Throughout</b>	Yes
<b>Does the means of egress appear deficient?</b>	
Exiting from the secondary exit down the wooden ADA ramp is compromised by the panic hardware and sticky lock and door problems.

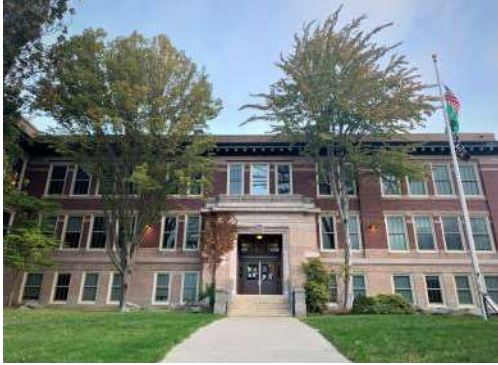
**McDonald International**  
144 NE 54th St SEATTLE, WA 98105

CSA - Overall, the school is in near excellent condition. There is minor wall and door surface scuffing and chipping of the wall finish at the main stairwells.

MEP - Main Building: HVAC has upgraded condensing boilers and pumps, newer domestic hot water heaters, with some upgraded domestic piping. Building has fire sprinklers installed throughout entire building. Entrance key card readers with surveillance cameras were installed new in 2020. The power service/distribution equipment is old and may warrant upgrading or replacement. The fire panel was upgraded in late 2000s/early 2010s. The lighting in good condition. Gym building: HVAC consists of a two wall mounted heat pumps feeding the open gym area. No domestic hot water to the gym building. There is drainage added to front entrance of building for pavement runoff. Gym building reportedly has had some communication issues with main building with the intercom and phone. Building has no fire sprinkler system installed, only notification bells and buzzers.

<b>Site Perimeter Score</b>	1 - Excellent: fully secured perimeter
<b>Recommend Further Egress Analysis</b>	No
<b>Emergency Lighting Throughout</b>	Yes
<b>Does the means of egress appear deficient?</b>	
No, but could be improved by providing an ADA parking stall in the staff parking lot with access to the on-grade cafeteria door.

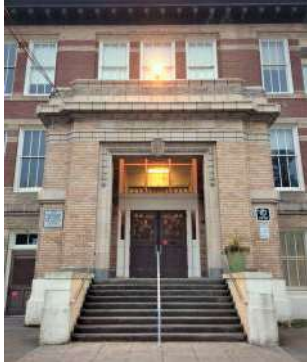
**McGilvra**  
1617 38 AV E SEATTLE, WA 98112

CSA - Main building is historic landmarked and in reasonably good condition. Major issues are the need for painting and protecting the wood windows (exterior paint flaking and wood deterioration), improving the energy performance of the envelope (historic single pane windows need better sealing, walls/roof appear uninsulated, doors lack effective energy seals), securing the exterior doors, upgrading interior/exterior doors to be ADA compliant, and remediating vinyl asbestos tile, and replacing all vinyl tile.

<b>Site Perimeter Score</b>	2 - Good: not fully enclosed but with controlled entries
<b>Recommend Further Egress Analysis</b>	Yes
<b>Emergency Lighting Throughout</b>	Yes
<b>Does the means of egress appear deficient?</b>	
Egress from the main building is only through the lower level via the elevator. All exit doors need to be retrofitted with panic hardware.

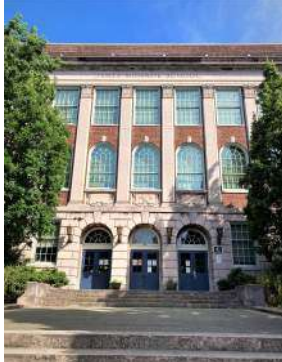
**Monroe (Salmon Bay)**  
1810 NW 65th St SEATTLE, WA 98117

CSA - Most systems, interior and exterior finishes are past their useful life and should be repaired or replaced.

MEP - The facility is served by MEP systems that are long beyond their useful life. Most spaces have a steam radiator with an older pneumatic control valves and either damaged fiberglass or asbestos insulation. The radiators are in poor condition and should be refurbished. The exhaust fans (located one level below the roof) are original to the building with antiquated motors and deteriorated intake/discharge louvers (approx. 40) located on the roof. The large air handling units are 1915 vintage with obsolete belts and antiquated original motors and minimally functional controls. There are constant volume air handling units serving the library and cafeteria, which are in fair condition. The steam boilers have been replaced and are in fair condition, but are controlled by a Siemens Apogee system that is not supported by the manufacturer. The domestic hot water heaters and mixing valves have been replaced, but the piping in the building is a mixture of newer copper plumbing and galvanized steel. The MDF is served by an older R22 refrigerant A/C unit. Lighting and lighting control are T8's with switches that should be replaced with a more modern system.

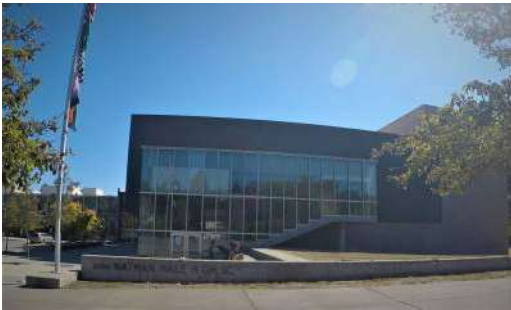
**Nathan Hale**  
10750 30 AV NE SEATTLE, WA 98125

CSA - Overall, the school is in good condition and only needs preventative maintenance. Most issues are cleaning and maintenance upkeep. Carpets are in fair condition and the VCT is in good condition with the exception of some areas. Athletic flooring in the men’s locker room is coming apart and in disrepair, whereas the flooring in the girls locker room is in good condition. Resilient base throughout is worn. Walls are scuffed and require patch and paint. Most of the bathrooms have been remodeled to comply with ADA.

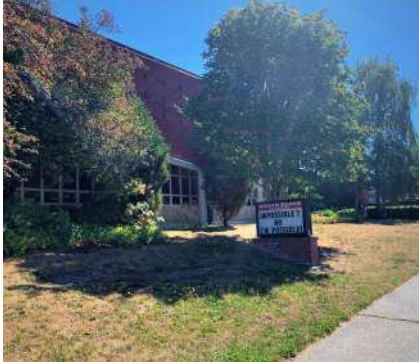
**North Beach**  
9018 24 AV NW SEATTLE, WA 98117

CSA - The school is an older building that has been well maintained but is having issues due to age of building and equipment. The facility is past its useful life and needs replacement. Issues with storm drainage and erosion along the western edge of the property. Issues with water penetration between classroom wings and taller central structure. Doors are non-ADA compliant. Windows are single pane glazed. Trees are overgrown and allow climbers onto the building roof.

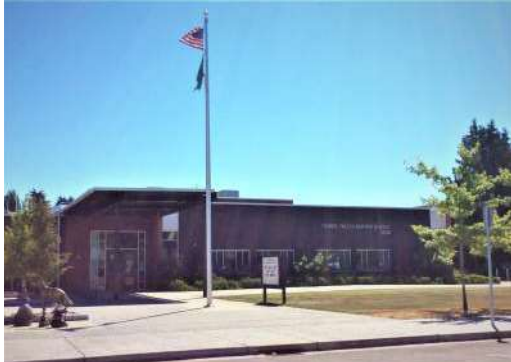
**Olympic Hills**  
13018 20th Ave NE SEATTLE, WA 98125

**CSA** - The school overall is in excellent condition. Interior and exterior finishes are excellent, durable and well-maintained. The notable exception is that the resilient base corners have come off at about 40% or greater of locations, primarily in the corridors, but also other rooms. Noted 3 cases where the drywall corner was torn partially off.

**MEP** - The MEP systems at Olympic Hills appears to be in good condition. The HVAC system is a highly efficient geothermal water source heat pump system. The electrical is a standard 480/277 volt service with stepdown transformers for 208/120 volt. Data telecom equipment is in like new condition and appears to be in working order. All equipment appears to be in good condition. The fire alarm and fires sprinkler system testing appear to be out of date.

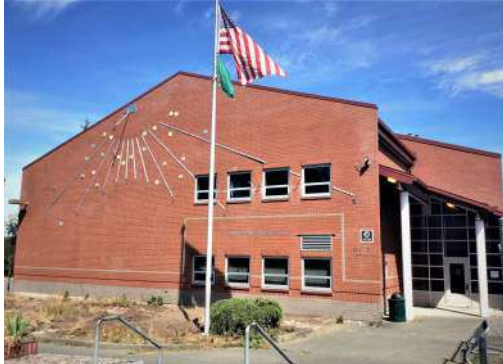
**Olympic View**  
504 NE 95 ST SEATTLE, WA 98115

<b>BCA Executive Summary</b>	
<p>CSA - The school is older and the finishes are showing extensive wear. None of the classroom casework appears to be accessible. Many of the classroom walls have scuffs, dings, and torn drywall facing. School does not appear to be fully ADA compliant and a comprehensive ADA evaluation should be completed soon and improvements made. New finishes should be considered in the next 5 years.</p>	
<p>MEP - HVAC system/controls upgrade included newer heat pumps for heating and cooling installed in 2014 for classrooms. The boiler is original and in need of upgrades. Newer AO Smith hot water heaters installed 2017. Kitchen still original from 2008. Electrical system is at maximum capacity and should be upgraded.</p>

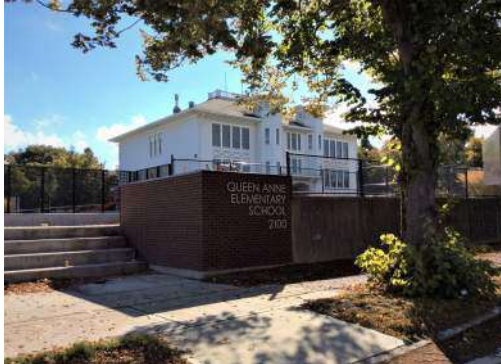
<b>Queen Anne</b> 411 Boston St. SEATTLE, WA 98109
---

**CSA** - The new addition and associated sitework is in excellent to good condition. The older 1922 and 1903 buildings are sound, but have worn surface conditions, with historic character. Older buildings are likely not well insulated. The windows are single pane, though they are wood and have spring metal seals. The 1903 building has some damage to the exterior stucco in a few locations that warrant repair. Site is in good condition overall.

**Does the means of egress appear deficient?**  
 Egress at the 1903 building is challenging due to the basement ramp access. The ramp is relatively narrow and has a corner turner to access the entry door.

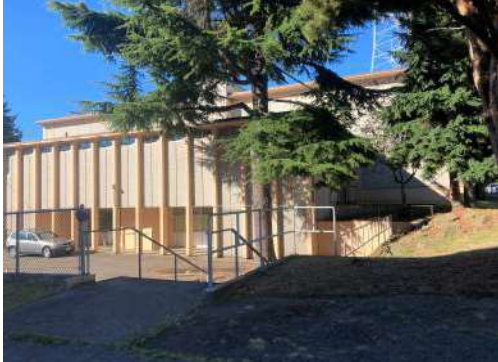
**Queen Anne Gym**  
1431 2nd Ave N SEATTLE, WA 98109

CSA - Many of the facility systems and components are past their useful life. Interagency has interim spaces developed and maintained for the current limited use. These spaces include several classrooms, lounging area, and the gym. The back basement (former shower/locker/office areas) of the building is derelict with exposed bolts from the slab creating trip hazards. This area is "off-limits" and not maintained.

<b>Site Perimeter Score</b>	5 - Unsatisfactory: no perimeter security
<b>Recommend Further Egress Analysis</b>	No
<b>Emergency Lighting Throughout</b>	No
<b>Does the means of egress appear deficient?</b>	
Yes

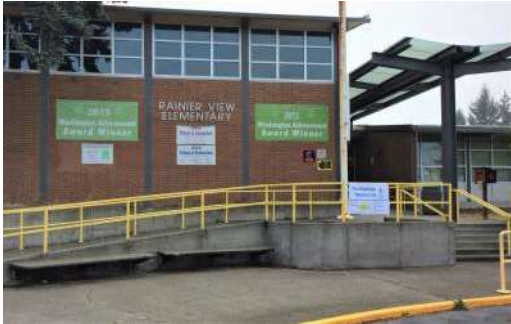
**Rainier View**  
11650 BEACON AV S SEATTLE, WA 98178

**MEP** - The building is generally heated using fin tube radiators. A single air handling unit provides outside air to all the interior classroom and office spaces. The outside air fan is quite old and dirty and is manually turned on and off each day by the custodian. It appears that the VFD and controls may have failed. Replacement of the outside air handling unit is recommended. The lighting appears to have been updated within the last 10 years. The electrical distribution systems also appear newer. Access controls are not provide, but the security alarm system appears to be functioning along with the fire alarm.

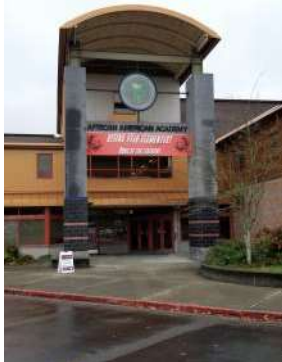
**Rising Star**  
8311 BEACON AV S SEATTLE, WA 98108

CSA - At the time of this assessment, the building was under construction in some areas, dealing with past roofing issues. Generally, the exterior of building appears sound with no visible defects. The interiors are in decent condition, but beginning to show their age with normal wear and tear. Some overgrowth around site, but generally in good condition.

MEP - The HVAC system is a four pipe air handling system with water cooled chillers and a cooling tower to make chilled water. Gas fired cast iron boilers generate hot water. The Assistant Principal indicated there are some slightly hot rooms. It is suggested the building should be recommissioned to find incorrect issues related to temperature control. The lighting is generally fluorescent and appear to be in operating condition.

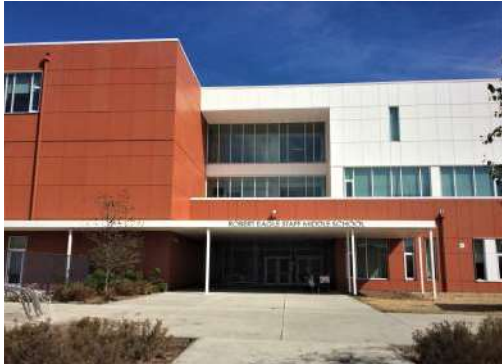
**Robert Eagle Staff**  
1330 N 90th St SEATTLE, WA 98103

CSA - This school is less than 3 years old and is in excellent condition, with some minor exceptions (e.g., painted walls and a few of the orange acoustical panels). Otherwise the finishes are in excellent condition. Virtually every room has paint damage where masking tape peeled the paint off down to the face of the gypsum board. This may be an indication that the primer was not dry or was not applied before the finish coats were applied. In addition, there are several acoustical panels that have torn edges.

MEP - HVAC is excellent condition and well maintained . Strategically placed mechanical rooms house blower coils feeding individual classrooms with a condensing loop from onsite HPs for heating and cooling. The fire sprinkler system and domestic water are new condition. Plumbing fixtures new energy efficient type installed new in 2017.

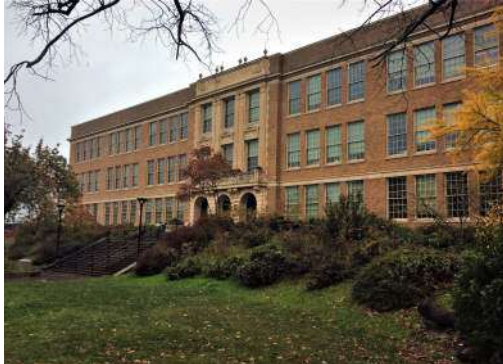
<b>Roosevelt</b> 401 NE Northgate Way SEATTLE, WA 98125
--

CSA - Overall, Roosevelt HS is in good condition with just a few significant issues. The primary consideration is the condition of the VCT flooring, which appears to have either a defective material or application issue. Approximately, 60% of the VCT floor has a darker shade finish that is obscuring the VCT tile colors and is wearing unevenly with blotches and scrapes showing through. The interior windows (i.e., door relites) in corridors and similar locations have wire glass, but are otherwise in good condition. ADA requirements are well met, if not exceptional compared to other SPS schools. The structure appears to be solid, with minor cracking observed in the foundation. A crack in the slab is appearing on the second floor of the 2006 addition in the northeast corner, which should be monitored. The thermal envelope appears to have been fully upgraded during the 2006 renovation. The facility is wearing well and is being well cared for by the occupants and facilities staff.

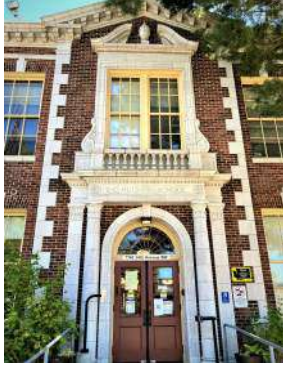
**Roxhill at E.C. Hughes**  
7740 34th Ave SW SEATTLE, WA 98126

<b>BCA Executive Summary</b>	
CSA - Roxhill Elementary program is now operating in the newly renovated, and historically landmarked, E.C. Hughes ES facility. Completed in 2018, E.C. Hughes is in good condition with a blend of modern and original, but still struggles with accessibility to some spaces and single pane glazing through much of the building.	
MEP - E.C. Hughes mechanical system is generally radiators with dedicated outside air system. The building appears to have been recently upgraded and renovated. Lighting appears to be in like new condition along with security, access control, fire alarm, fire sprinkler, electrical distribution and HVAC systems.

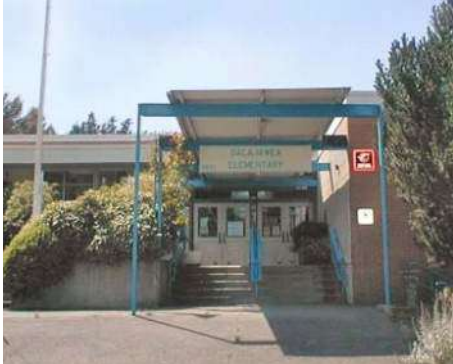
<b>Sacajawea</b> 9501 20 AV NE SEATTLE, WA 98115
---

BCA Executive Summary	
	<p>CSA - Overall, the condition of Sacagawea "poor" and the facility is due for replacement since it is outdated and deteriorating quickly. Although there have been some major upgrades in the past, (i.e. seismic bracing, limited ADA upgrade to bathrooms, various cosmetic improvements, etc.) there remain many deficiencies that will require high-dollar corrections. ADA upgrades are likely upwards of \$1.5 million alone, and some issues may not be able to be corrected. Energy efficiency upgrades (e.g., windows, doors, skylight openings) are also likely to cost millions.</p>
	<p>MEP - The HVAC system consists of newer Cleaver Brooks boilers and circulation pumps. However, the AHUs and ventilation are of original vintage and in need of upgrading to new high energy efficient type. Controls upgrades were completed back in early 2010s, however only some of the control valves for heating have been replaced and represent a combination of Siemens Apogee DDC with old pneumatic control valves. Lighting is a combination of incandescent, fluorescent and some LED bulbs in common spaces. Plumbing fixtures and sinks are old and deteriorated.</p>

<b>Site Perimeter Score</b>	2 - Good: not fully enclosed but with controlled entries
<b>Recommend Further Egress Analysis</b>	Yes. The school was originally designed and constructed prior to the acceptance of the ADA Guidelines. Many noncompliant issues are obvious but measurements should be taken to confirm.
<b>Emergency Lighting Throughout</b>	Yes
<b>Does the means of egress appear deficient?</b>	
Thresholds are noncompliant at exit doors. Steps to lower level are noncompliant. Exit doors are likely noncompliant. Measurements were not taken to confirm compliance.

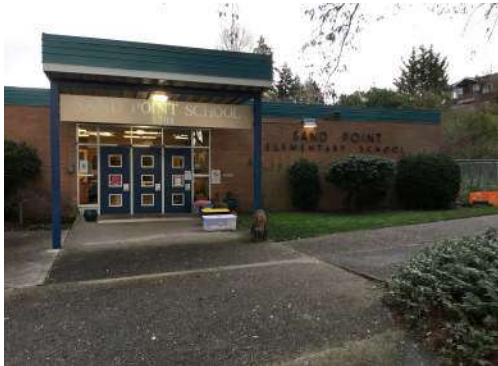
**Sand Point**  
6208 60 Ave NE SEATTLE, WA 98115

<b>BCA Executive Summary</b>	
<p>CSA - Sand Point is a late 1950s vintage, single story building, although appears to have had some seismic upgrade work. Exterior windows are single pane throughout. Some exterior doors (to covered play) are wood, hardware is old and will need replacement. The roof has been a long-term problem with visible cracks, bare areas and multiple soft spots. This should be addressed as a priority for preservation of the building.</p>	
<p>MEP - Newer benchmark condensing boilers, VRF driven hot water distribution pumps with Johnson Controls DDC upgrades were installed less than 8-9 years ago. Recent domestic hot water heaters were also upgraded and appear in good condition. Some major electrical upgrades in boiler room and lighting to classrooms are also apparent. However, security and public address/clock system could use upgrades. Fire suppression/protection is in good condition.</p>

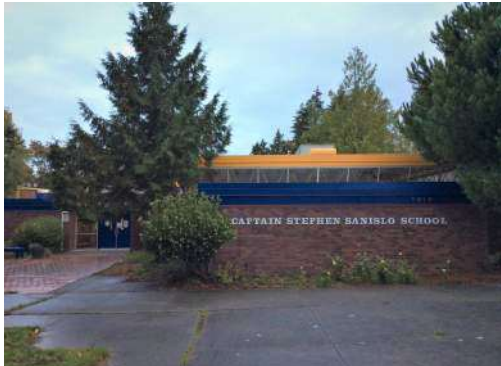
<b>Sanislo</b> 1812 SW MYRTLE ST SEATTLE, WA 98106
---

<b>Site Perimeter Score</b>	5 - Unsatisfactory: no perimeter security
<b>Recommend Further Egress Analysis</b>	Yes
<b>Emergency Lighting Throughout</b>	Unsure
<b>Does the means of egress appear deficient?</b>	
Not all exterior doors have panic bar hardware.

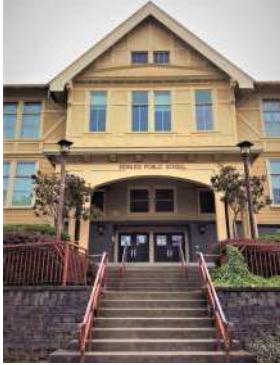
**Seward (TOPS)**  
2500 FRANKLIN AV E SEATTLE, WA 98102

<b>Site Perimeter Score</b>	3 - Fair: some uncontrolled entries
<b>Recommend Further Egress Analysis</b>	Yes
<b>Emergency Lighting Throughout</b>	Yes
<b>Does the means of egress appear deficient?</b>	
There is no area of refuge, no evacuation assistance chairs for moving someone down the stairs during an emergency.

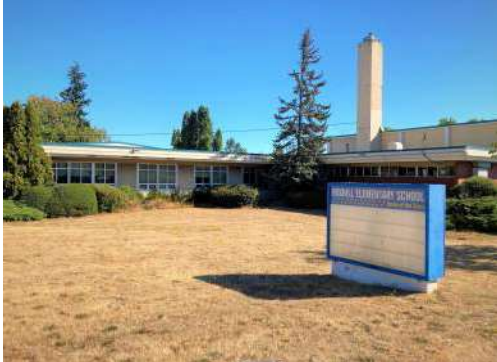
**SW Interagency Academy at Roxhill**  
7740 34th Ave SW SEATTLE, WA 98126

<b>Site Perimeter Score</b>	3 - Fair: some uncontrolled entries
<b>Recommend Further Egress Analysis</b>	No
<b>Emergency Lighting Throughout</b>	Did not observe any 'stand alone' emergency lighting, but fixtures may be on a different circuit. The fire alarm system looked relatively new so I would image emergency lighting would have been part of that upgrade.
<b>Does the means of egress appear deficient?</b>	
Steep ramps, noncompliant door hardware, inadequate door clearances.

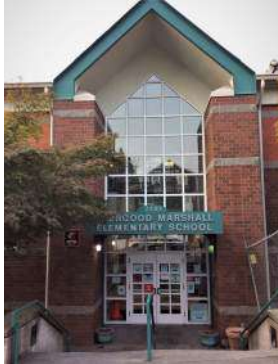
**Thurgood Marshall (Colman)**  
2401 S IRVING ST SEATTLE, WA 98144

CSA - Thurgood Marshall brick cladding in good condition. 3-tab composition roofing on the pitched roof appears to be in reasonable condition. Overall, building systems, materials/finishes appear well-maintained, reflect their age, but remain functional.

MEP - The mechanical system consists of hydronic heat pumps that were installed approximately 30 years ago. The system is at the end of normal useful life and should be considered for an HVAC retrofit within the next five years. The electrical distribution system appears to be in good working order, installed in 1991. The data and communication systems appear to be functional and with no noted issues. Security and access controls and devices appear to be functional and available staff did not report any issues.

<b>Site Perimeter Score</b>	3 - Fair: some uncontrolled entries
<b>Recommend Further Egress Analysis</b>	No
<b>Emergency Lighting Throughout</b>	Yes
<b>Does the means of egress appear deficient?</b>	
Yes

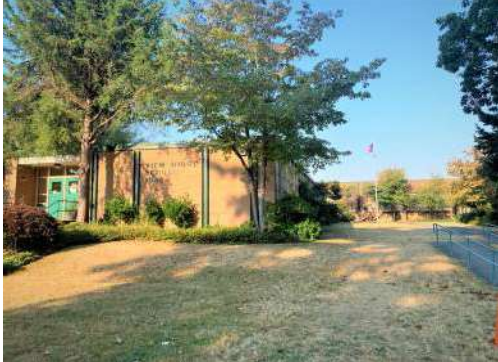
**View Ridge**  
7047 50 AV NE SEATTLE, WA 98115

<b>Facility Need - CSA</b>	Total Replacement
<b>Facility Need - MEP</b>	Major Modification
<b>Facility Needs - LEA</b>	Total Replacement

CSA - View Ridge ES is a single story, Roman brick masonry building constructed in 1947 with a building addition in 1960. It looks to have recently had a seismic retrofit. The site conditions range from good to poor; with beautiful landscaping, but aging walkways, sprawling and areas of erosion at site walls and paved play areas. The exterior windows and doors are almost exclusively original, with old hardware and poor energy inefficiency. The interiors finishes, spaces, hardware, fixtures and equipment are all very dated and beyond useful life.

MEP - The heating system consists of old boilers and some York RTUs that have deteriorated from weather and use and currently at the end of life expectancy. There is no cooling in the building. The DDC system is from the early 2000s and not expandable with some parts not even available, therefore beyond useful life. The domestic hot water heaters and piping remains in good condition. Lighting is fair with a combination of T-8 and some incandescent lighting. No fire sprinklers have been installed in the majority of the building's areas.

<b>Site Perimeter Score</b>	4 - Poor: many uncontrolled entries or ineffective perimeter fencing
<b>Recommend Further Egress Analysis</b>	No
<b>Emergency Lighting Throughout</b>	Yes
<b>Does the means of egress appear deficient?</b>	
Non ADA compliant hardware.

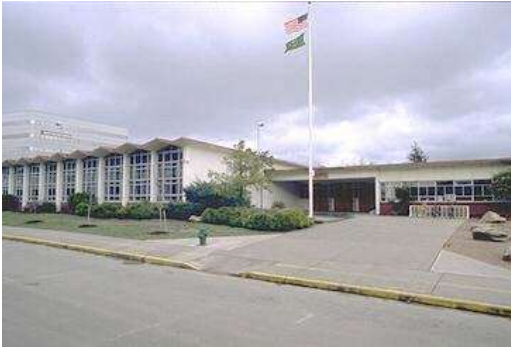
**Washington**  
2101 S JACKSON ST SEATTLE, WA 98144

<b>Facility Need - CSA</b>	Total Replacement
<b>Facility Need - MEP</b>	Total Replacement
<b>Facility Needs - LEA</b>	Total Replacement

<b>BCA Executive Summary</b>	
<p>CSA - Washington MS is generally worn out and outdated for modern schools. There are several areas showing damage to concrete roof beams/panels, columns and wall panels. Roofing is near the end of its useful life. Exterior windows are non-thermal frames and single pane glazing. Most interior finishes and equipment is aged and worn.</p>	
<p>MEP - The HVAC system is comprised of unit ventilators with hydronic heating. Larger areas are served by two pipe air handler's. The electrical system is antiquated and due to be replaced. The building controls utilizes an outdated electro pneumatic control system. The intercom system is old technology and beyond useful life as most systems throughout the school.</p>

<b>Site Perimeter Score</b>	5 - Unsatisfactory: no perimeter security
<b>Recommend Further Egress Analysis</b>	Yes
<b>Emergency Lighting Throughout</b>	Yes
<b>Does the means of egress appear deficient?</b>	
No

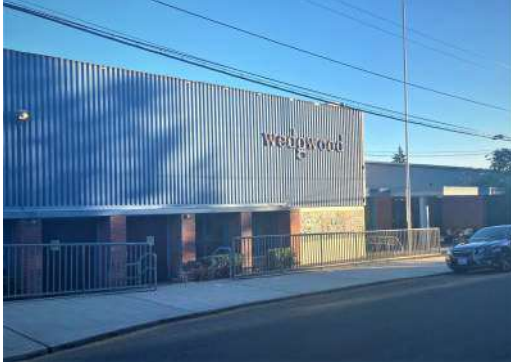
<b>Wedgwood</b> 2720 NE 85 ST SEATTLE, WA 98115
--

<b>Facility Need - CSA</b>	Major Modification
<b>Facility Need - MEP</b>	Major Modification
<b>Facility Needs - LEA</b>	Total Replacement

CSA - At the time of this review, the roofing was being replaced along with some seismic improvements. It was not clear if exterior doors were to be replaced as part of the project. Overall the building is in fair condition. Some windows have been replaced, but the majority are still steel sash, single pane units. Interior finishes and casework are old worn and flooring is VAT. The play structures are in disrepair and damaged.

MEP - The building's HVAC system is comprised of a steam heat serving cabinet fan heaters with fin tube radiators and fan coils. The hallways are used as a relief air pathway. The electrical system is old and does not have GFCI or TVSS protections. The fire sprinkler system is in poor condition. The air compressor runs constantly according to the custodian. The fire alarm panel is newer, yet the devices appear to be older, but still operational. The plumbing fixtures are old and worn. Overall the building systems function, yet the heating system appears to be old and in need of replacement.

<b>Site Perimeter Score</b>	4 - Poor: many uncontrolled entries or ineffective perimeter fencing
<b>Recommend Further Egress Analysis</b>	Yes
<b>Emergency Lighting Throughout</b>	No
<b>Does the means of egress appear deficient?</b>	
No

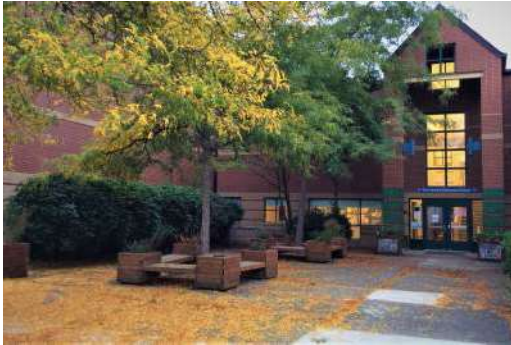
**West Seattle ES**  
6760 34th Ave SW SEATTLE, WA 98126

<b>BCA Executive Summary</b>	
<b>CSA</b>	This two-story elementary building is scheduled for addition/modernization starting in the summer of 2021. The building is in fairly good shape, but showing its age with normal wear and tear. Some settlement/cracking is evident on the slab on grade, at the east end of hallway on the 2nd floor.
<b>MEP</b>	The HVAC system is generally comprised of water cooled heat pumps with a electric boilers and a cooling tower. The mechanical system is original and nearing the end of it's 30 year life. The electrical distribution, security and access, data, intercom, and other electrical systems are good working order. The fire sprinkler system appear to only cover half of the first floor of the building. No fire sprinklers exist in the activities wing or the entire second floor and mechanical mezzanine.

<b>Site Perimeter Score</b>	4 - Poor: many uncontrolled entries or ineffective perimeter fencing
<b>Recommend Further Egress Analysis</b>	No
<b>Emergency Lighting Throughout</b>	Yes. At least one older unit in the hallway was not working.
<b>Does the means of egress appear deficient?</b>	
No

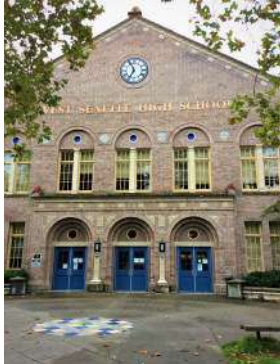
**West Seattle HS**  
3000 CALIFORNIA AV SW SEATTLE, WA 98116

CSA - Some system in the older building and the new addition are in reasonably good condition. The entire building is being reroofed. Seismic upgrades and insulation have been installed at the attic level of the older building. The landmarked, historic wood single pane windows and frames are in reasonably good condition and operate well. However, the exterior and interior paint finishes are in poor condition. The weather/thermal seals are inadequate. The exterior masonry is in good condition. Interior finishes range from poor to good. The flooring is in poor condition and needs complete stripping and refinishing throughout. Walls need patch and refinishing. CMU interior walls need to be cleaned and sealed. Exterior and interior doors and frames need to be refinished. Interior glazing is wireglass at the corridors, commons and library overlooks, and miscellaneous other areas.

MEP - The HVAC system is generally a four pipe fan coil system with heating and chilled water. Two standard efficiency fire tube boilers and a single water cooled chiller provide heating and cooling water for the building. Classrooms are heated by fin tube radiators at exterior walls. The building mechanical and electrical systems were updated in around 2002 and all systems appear to be operating adequately, with the exception that the building is over pressurized. This is likely due to inadequate or inoperable relief air system/pathways.

<b>Site Perimeter Score</b>	4 - Poor: many uncontrolled entries or ineffective perimeter fencing
<b>Recommend Further Egress Analysis</b>	No
<b>Emergency Lighting Throughout</b>	Yes
<b>Does the means of egress appear deficient?</b>	
No

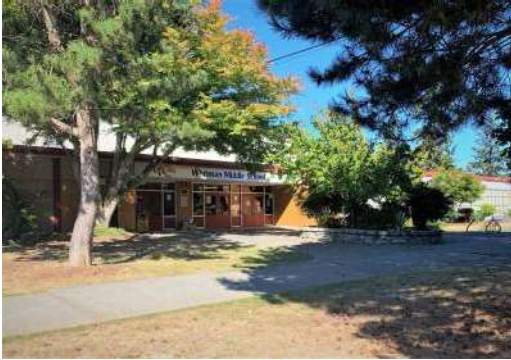
**Whitman**  
9201 15 AV NW SEATTLE, WA 98117

<b>Facility Need - CSA</b>	Total Replacement
<b>Facility Need - MEP</b>	Major Modification
<b>Facility Needs - LEA</b>	Major Modification

CSA - The school is overall old, worn, and at the end of its useful live.

<b>Site Perimeter Score</b>	3 - Fair: some uncontrolled entries
<b>Recommend Further Egress Analysis</b>	No
<b>Emergency Lighting Throughout</b>	No
<b>Does the means of egress appear deficient?</b>	
Yes

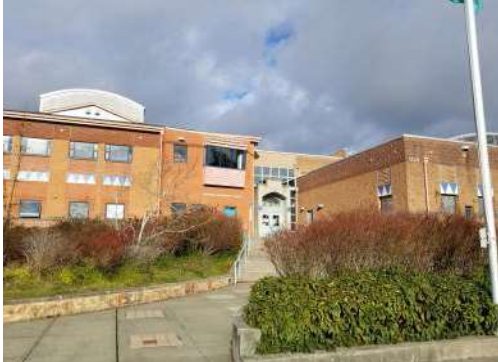
**Whittier**  
1320 NW 75 ST SEATTLE, WA 98117

CSA - School is generally in good shape. There are some structural issues with the slab on grade where it is cracked and telegraphing through the VCT tile damaging the tile. Classroom and corridor walls flooring and ceilings are in surprisingly good condition, though there is some wall damage and some carpet staining. Stairwells are a bit worn with treads worn, some cove base damaged, safety strips worn away, and worn paint on handrails. Exterior windows, doors and masonry are in good condition. The membrane roofing is in good condition, however the three-tab composition roofing is nearing the end of its useful life. There have been roof leaks. The playfield is in good condition. Landscaping lacks maintenance and watering.

MEP - HVAC is generally a 4-pipe fan coil unit system. Standard efficiency boilers and a chiller provide hot and chilled water. The electrical system is standard 480 volt with distributed transformers for 208 volt service. There is evidence of leaking pipes around a small set of fan coil units. The leaks appear to be coming from the heating water system. Security and access control appear to be functioning. The custodian mentioned that the DDC system is only visible at the school and not back at the district headquarters.

Site Perimeter Score	2 - Good: not fully enclosed but with controlled entries
Recommend Further Egress Analysis	No
Emergency Lighting Throughout	Yes
<b>Does the means of egress appear deficient?</b>	
No

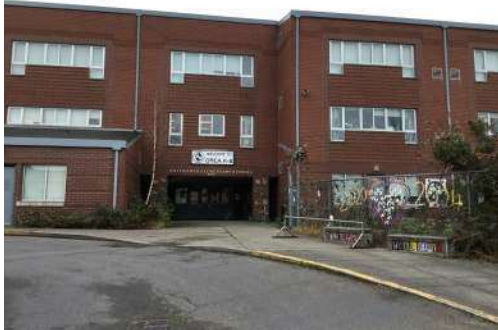
**Whitworth**  
5215 46 AV S SEATTLE, WA 98118

<b>Facility Need - CSA</b>	Minor Modification
<b>Facility Need - MEP</b>	Minor Modification
<b>Facility Needs - LEA</b>	Total Replacement

<b>BCA Executive Summary</b>	
CSA - Orca K-8 overall is in good to fair condition with several minor maintenance items needed.	
MEP - Heating system consists of heat pumps in classrooms transferring heat via a condensing loop system with older boiler and chilling tower tempering condensing loop controlled through an older Siemens DDC system. Some control valves need to be replaced, however system is in fair condition. HVAC system warrants upgrading. Fire sprinklers throughout building with strobes and horns. Newly upgraded fire control system installed in fire electrical room, however, not fully transferred over from old 1988 system. Lighting is mixture of T-8 and T-12 fluorescent lighting and should be upgraded. Exterior lighting could benefit from additional fixtures for dark areas.
