Aki Kurose Middle School Addition and Modernization Project

Draft Project SEPA Checklist

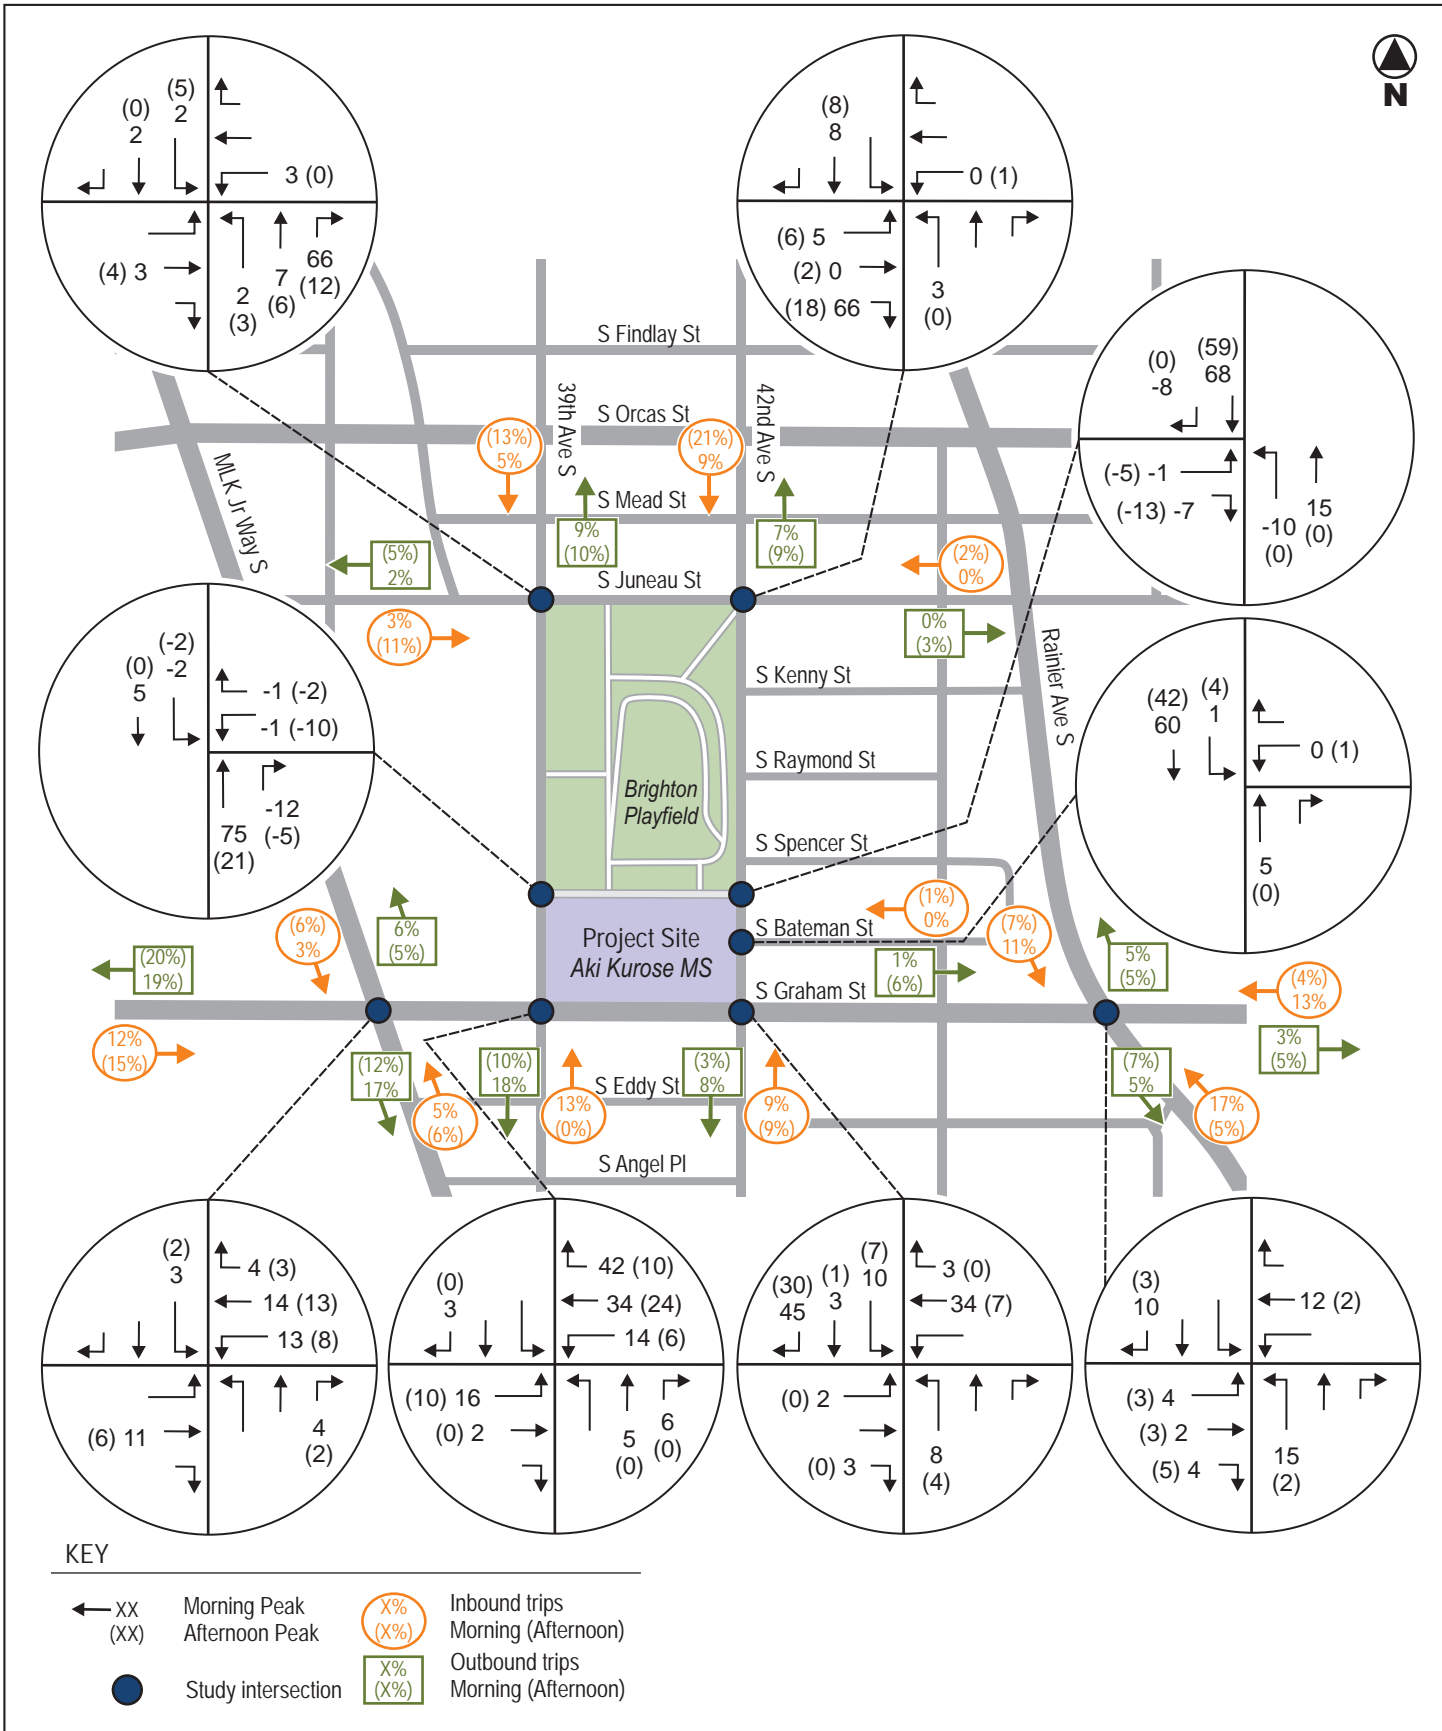
Figure 7
Net Project Trip Distribution and Assignment
Morning and Afternoon Peak Hours

Project trip distribution patterns and assignments were developed for the morning and afternoon peak hours using a combination of the school’s enrollment and draw areas and traffic counts and directional patterns at intersections adjacent to the site. The derived trip distribution patterns were applied to the estimated net increased in school-generated trips to determine the net changes in trips expected with the project. Figure 7 shows the traffic distribution patterns and assignments of the changes in trips for the morning and afternoon.

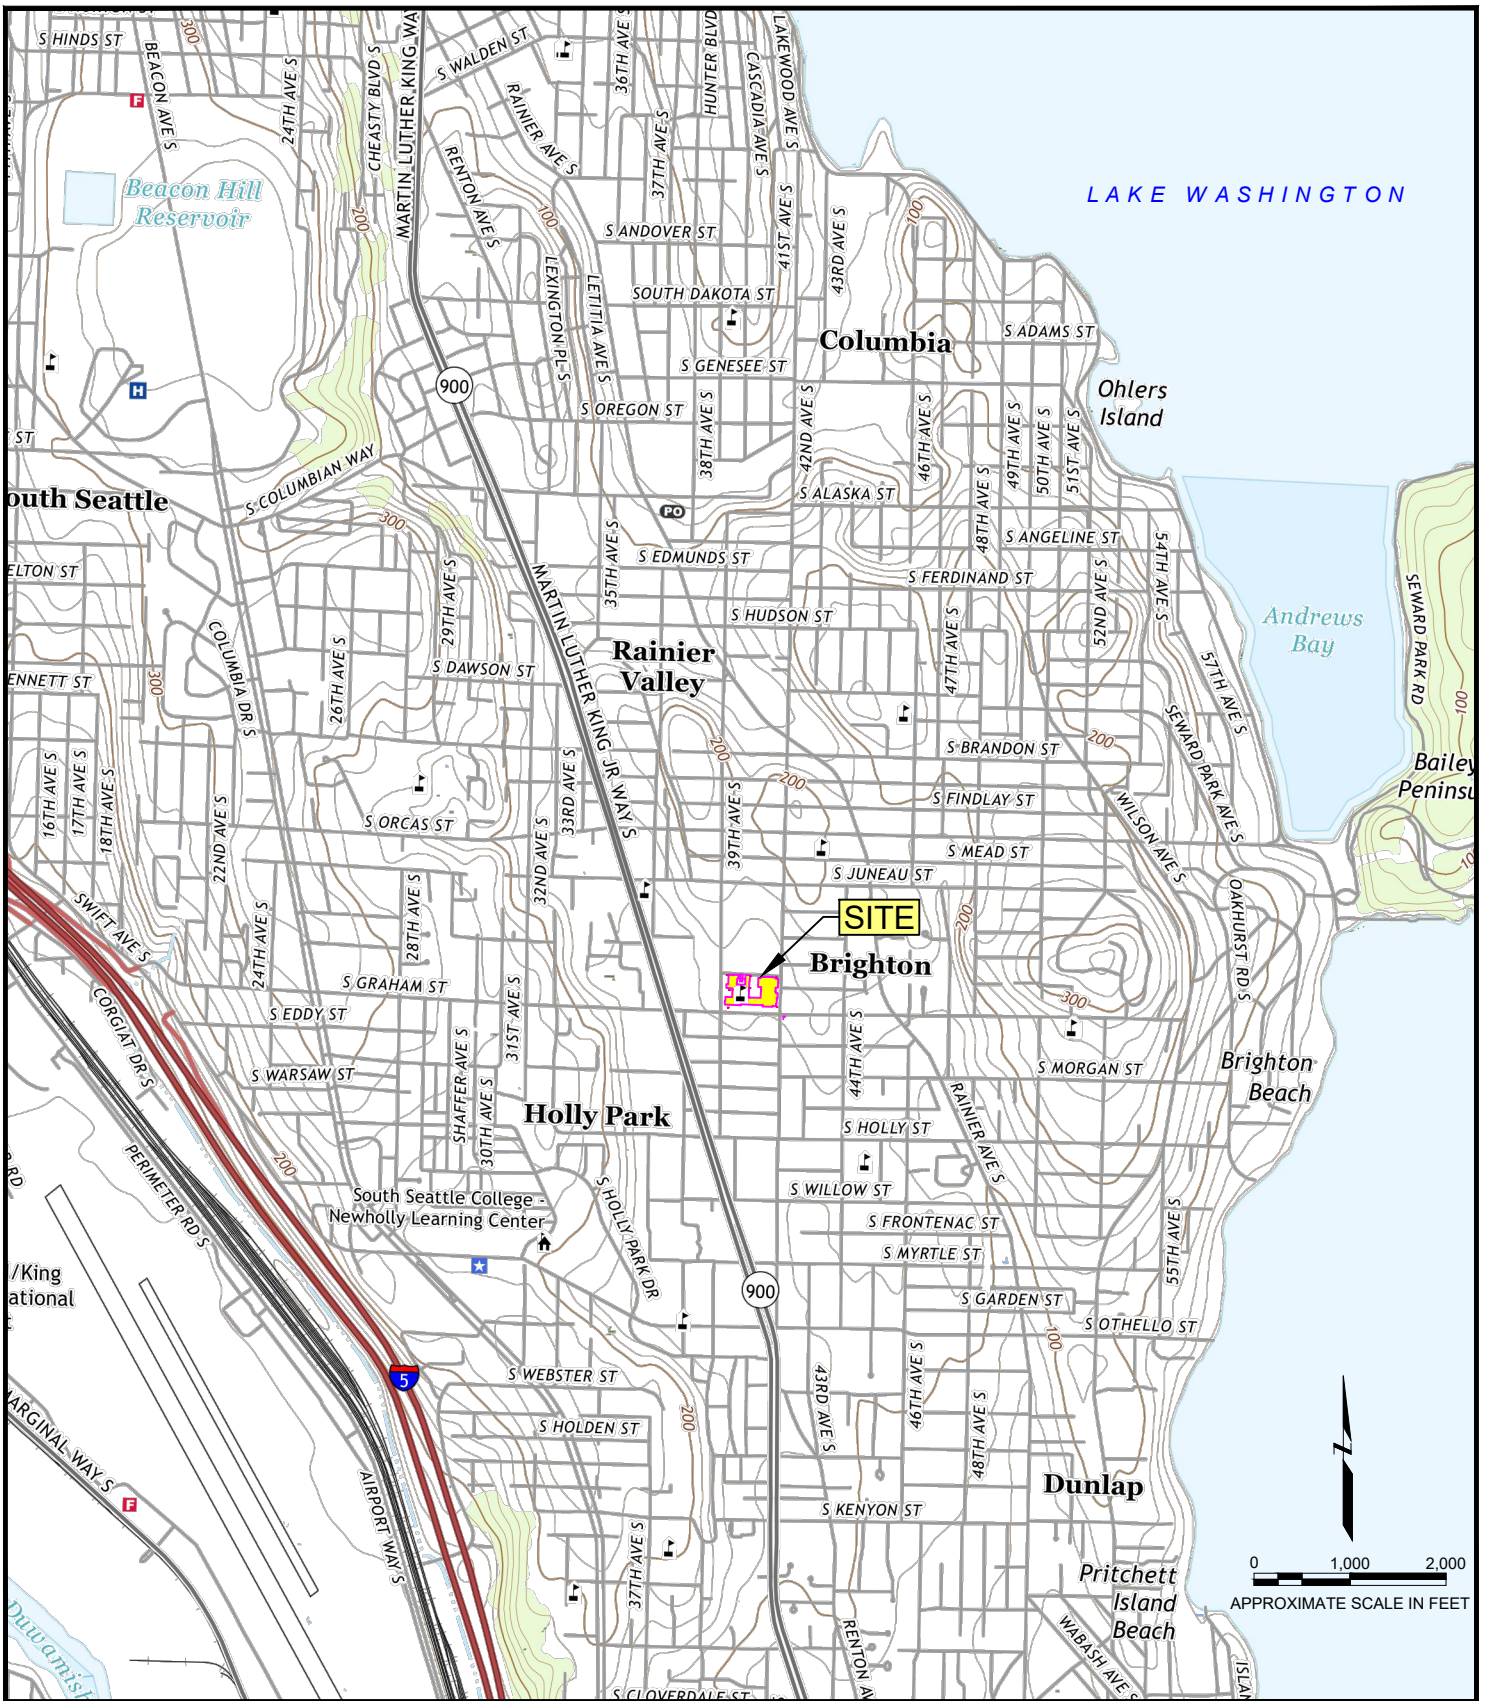
CLIENT SEATTLE PUBLIC SCHOOLS	 	PROJECT AKI KUROSE MIDDLE SCHOOL GEOTECHNICAL DESIGN	DATE FEBRUARY 2023
WSP USA Environment & Infrastructure Inc. 4020 Lake Washington Blvd NE, Suite 200 Kirkland, Washington 98033		TITLE SITE VICINITY	SCALE AS SHOWN
			PROJECT NO. PS22205930
			FIGURE 1

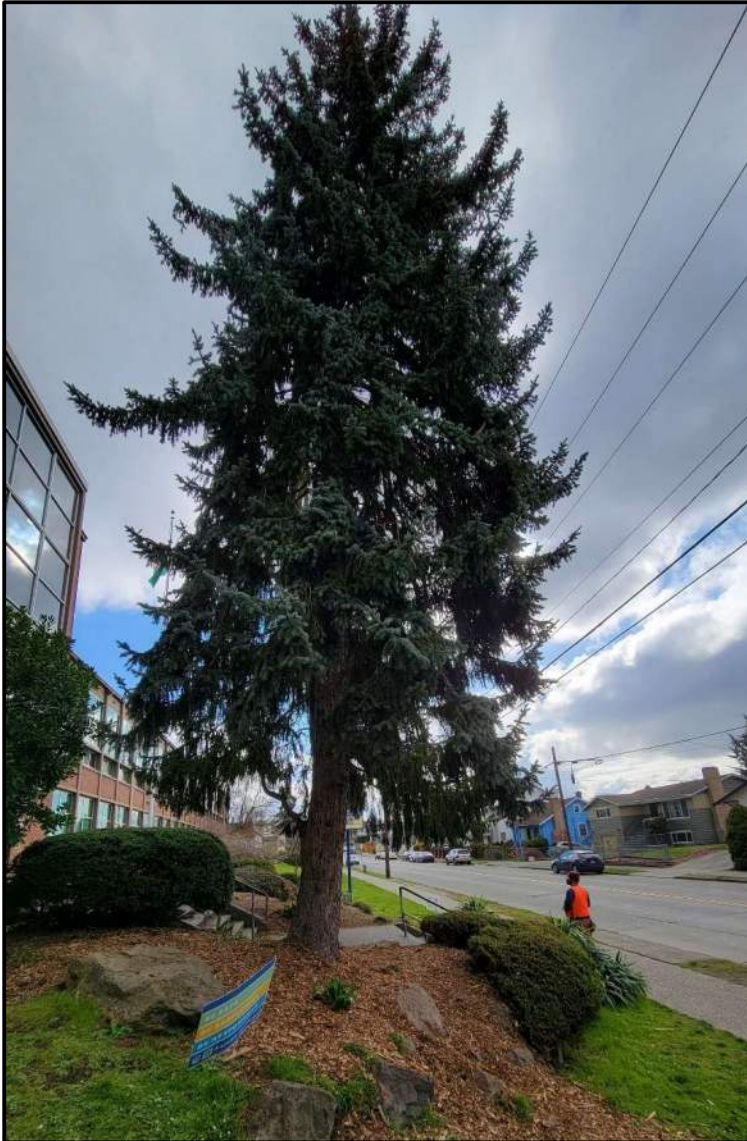
Photo 2. Tree 179 growing in a rockery and adjacent to the main stairway. The tree's roots are likely intertwined with the rockery and should be taken into consideration when designing and installing the new school entrance. (April 2023)

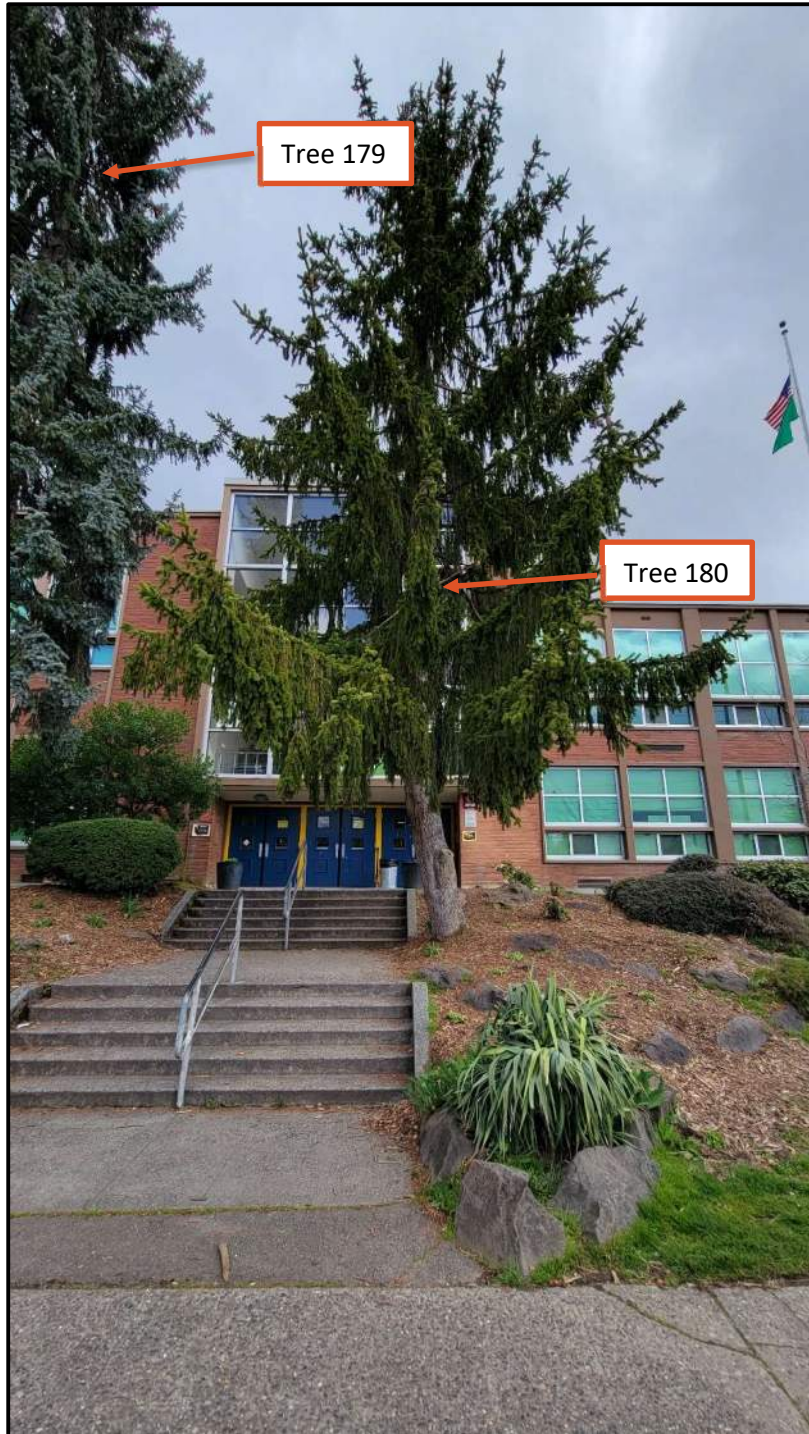
Photo 3. Tree 180 in front of the main stairway entrance. This tree likely has roots intertwined with the rockery and beneath the pathway. (April 2023)

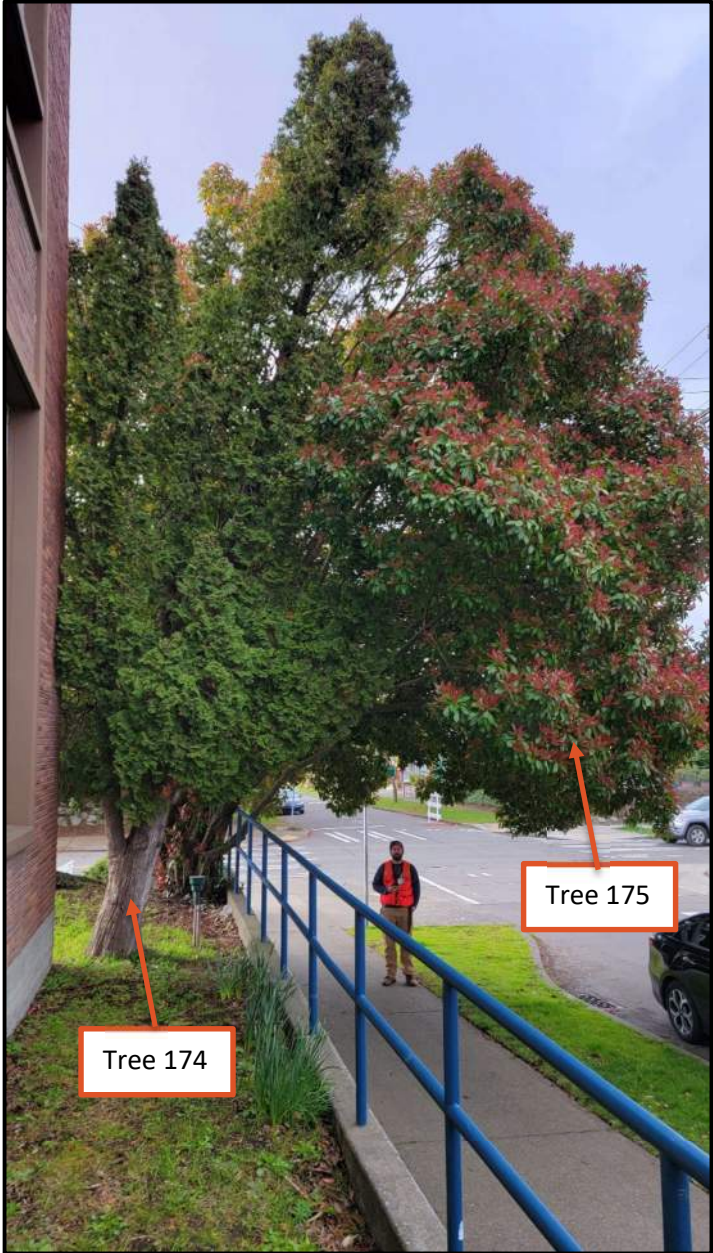
Photo 4. Trees 174 and 175 are growing adjacent to and are dependent on the retaining wall along 38th Ave S. (April 2023)

Tree 174 is a tier 3 arborvitae (*Thuja occidentalis*) tree and Tree 175 is an tier 3 Fraser photinia (*Photinia x fraseri*) tree. Both are growing above a retaining wall parallel to 38th Ave S on the southwest corner of the site (Photo 4). These trees are reliant upon the wall, which should be considered if the plans are to remove or alter this wall.

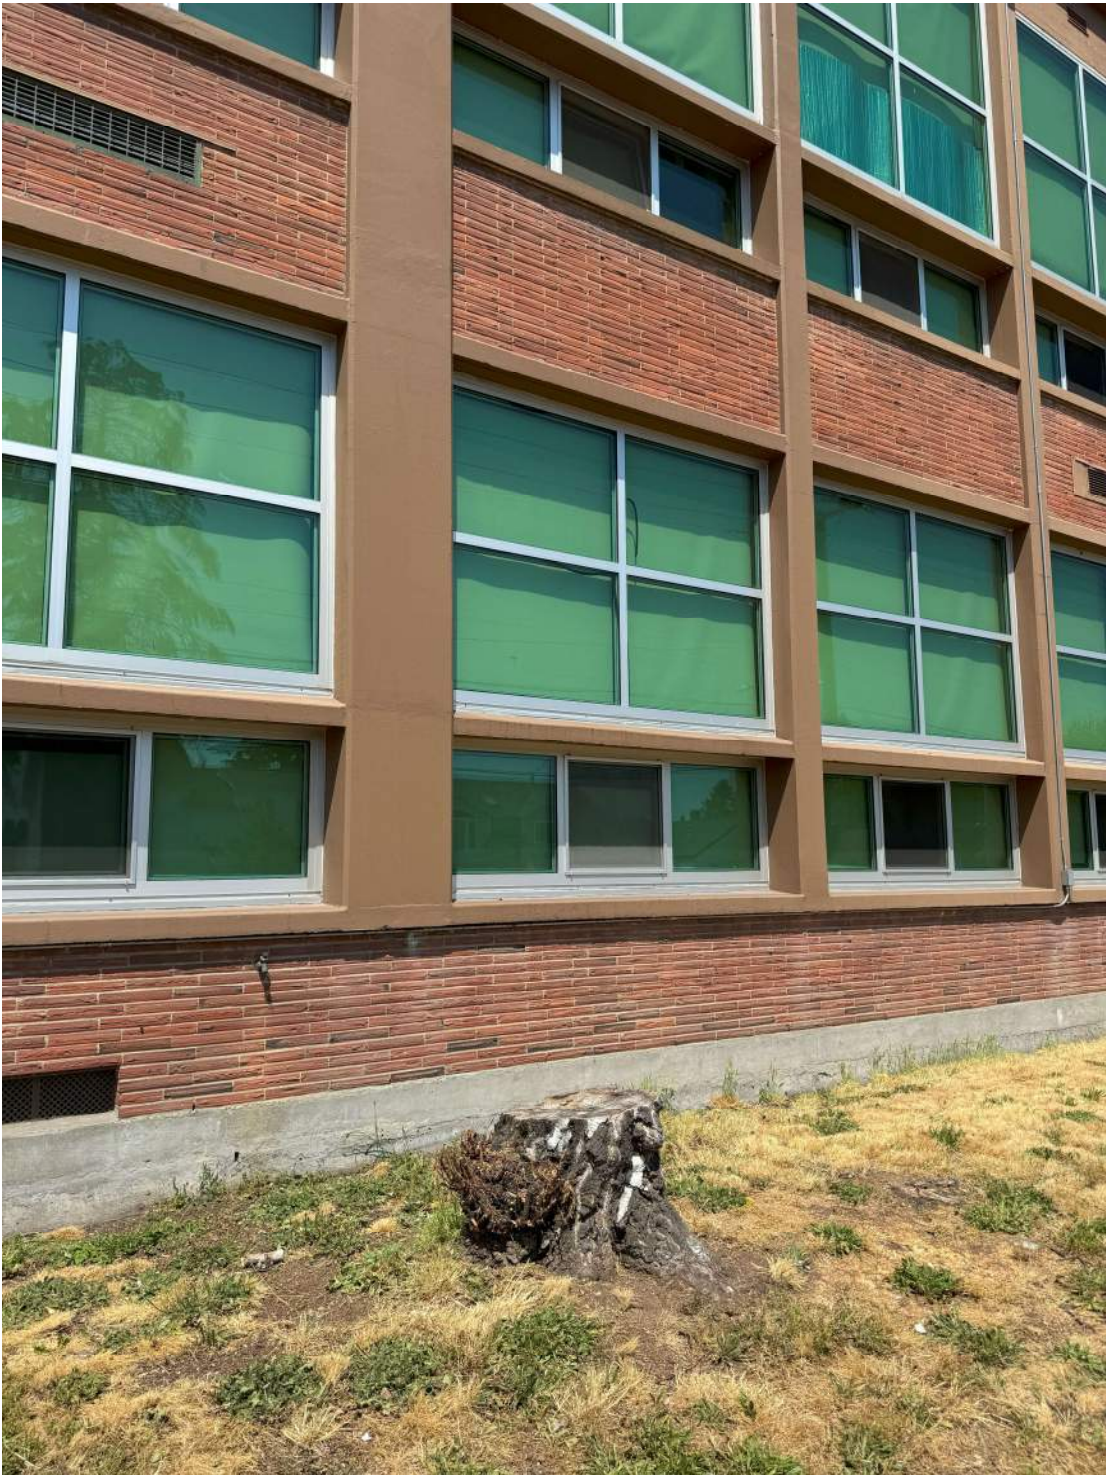
Tree 181:

July 11, 2024 – Tree 181 has been removed.

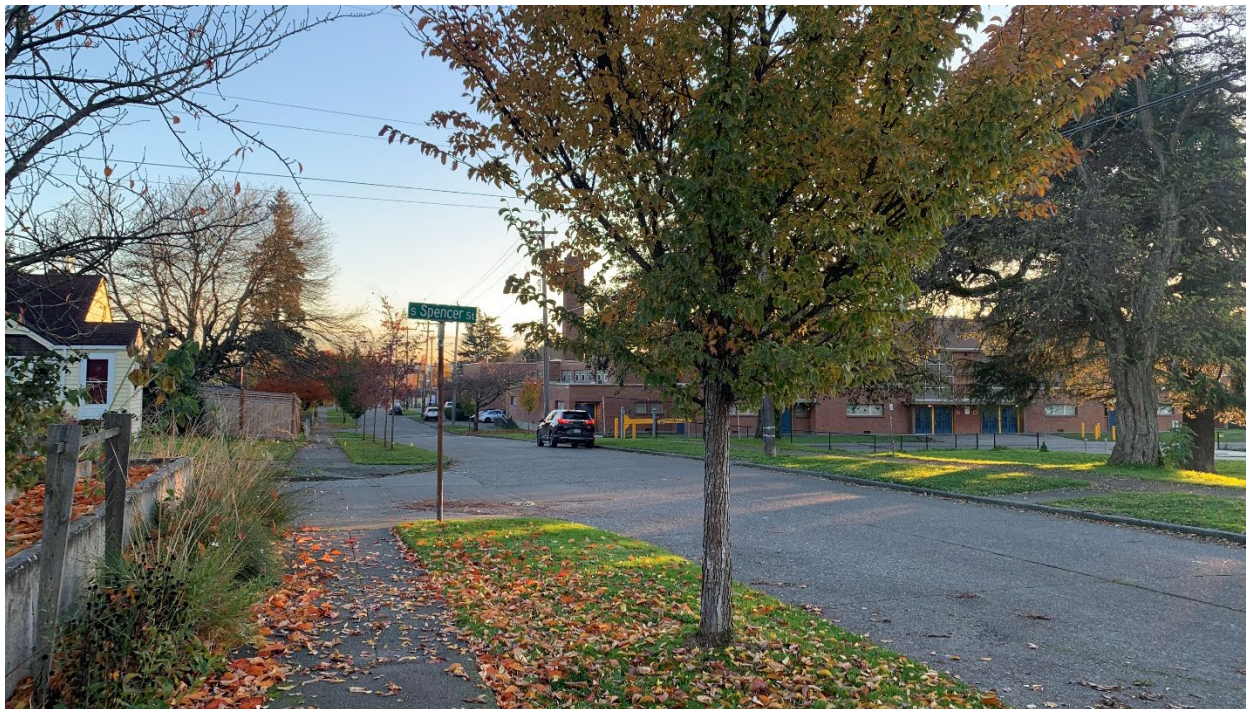
Photo 4

View of Project Site Facing Southwest from Residence Located at 4202 S Spencer.

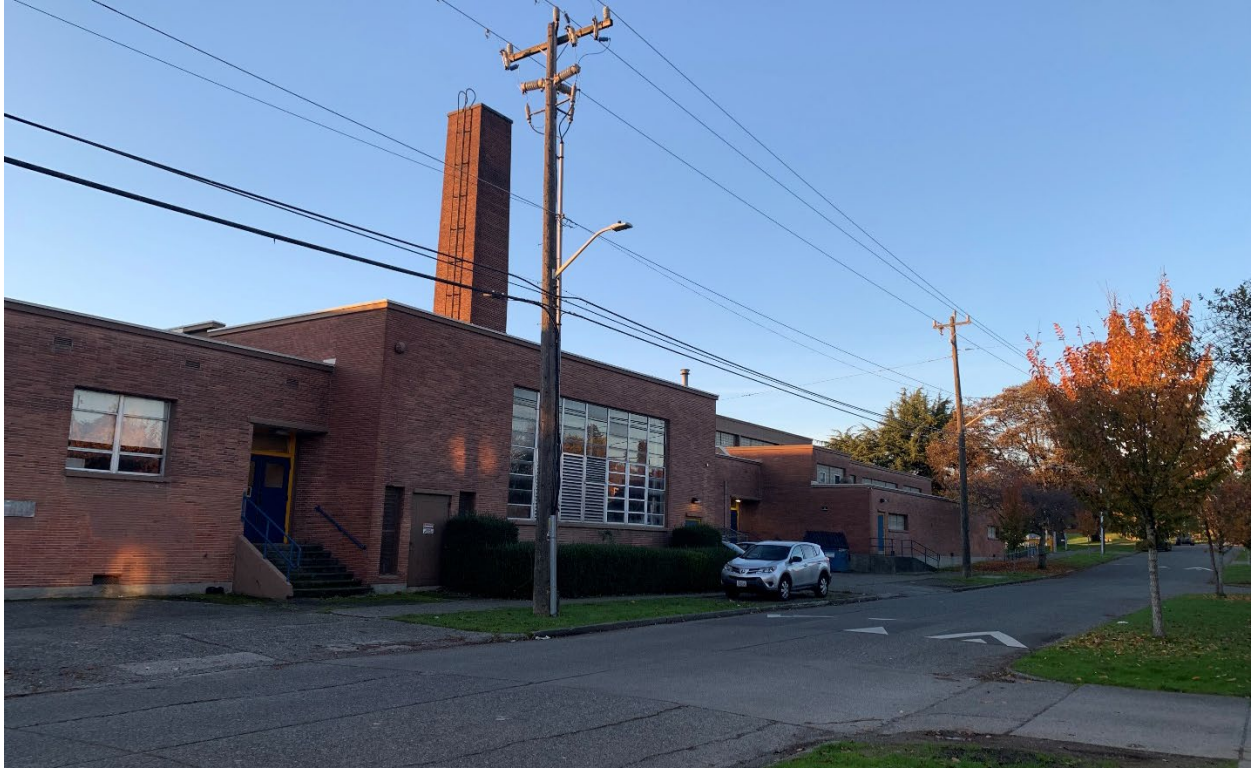
Photo 5

View of Project Site Facing Northwest from Residence Located at 4200 42nd Avenue S.

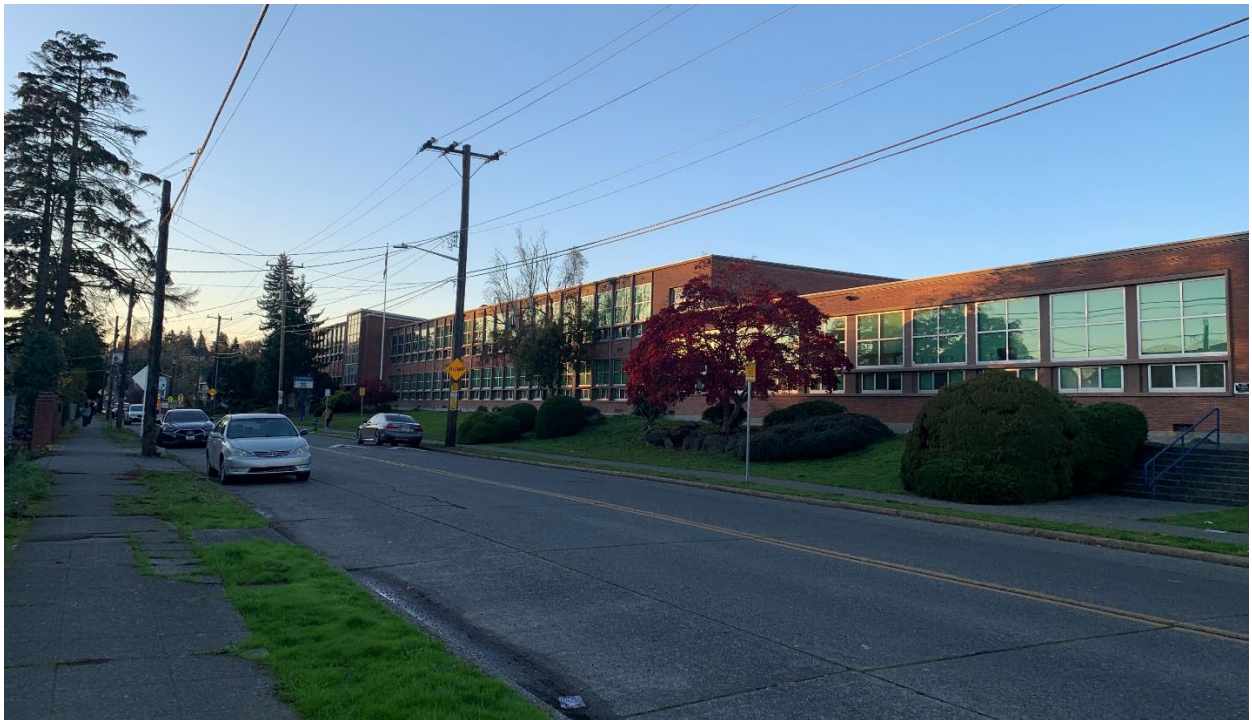
Photo 6

View of Project Site Facing Northwest from Corner of S Graham Street and 42nd Avenue S.

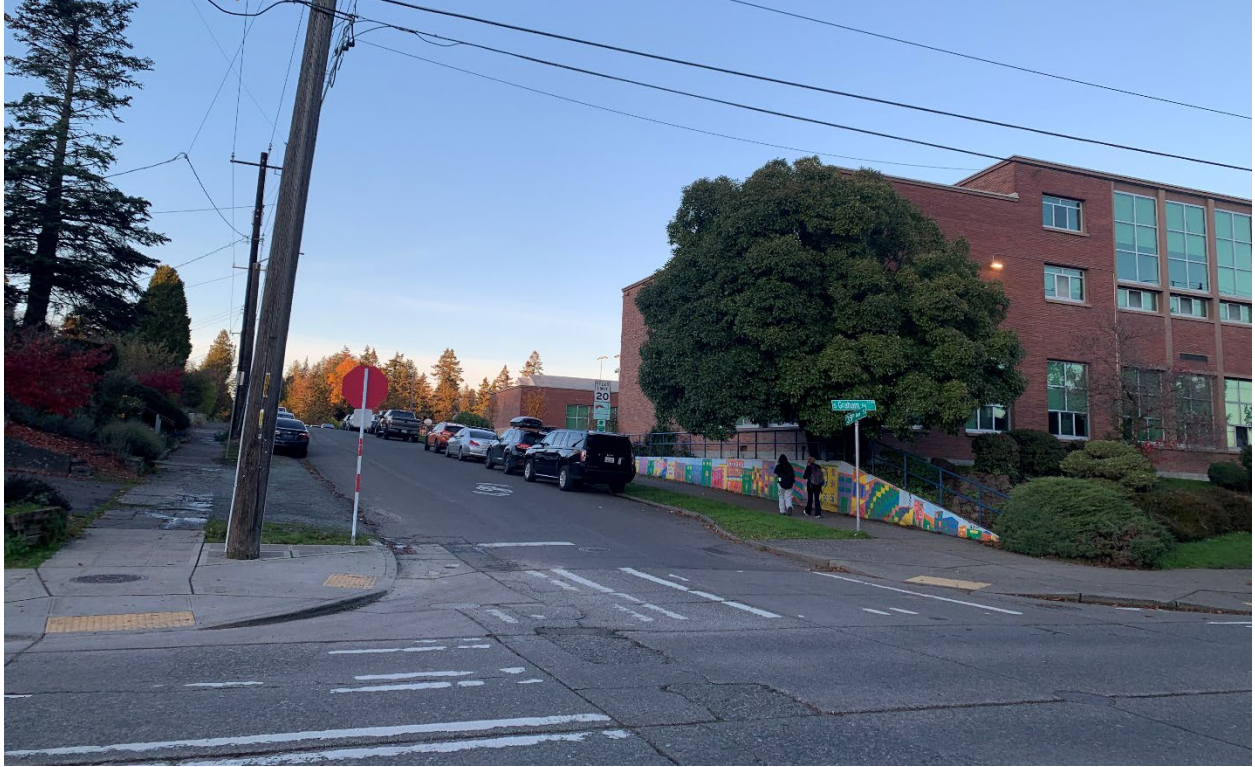
Photo 7

View of Project Site Facing North from Corner of S Graham Street and 39th Avenue S.

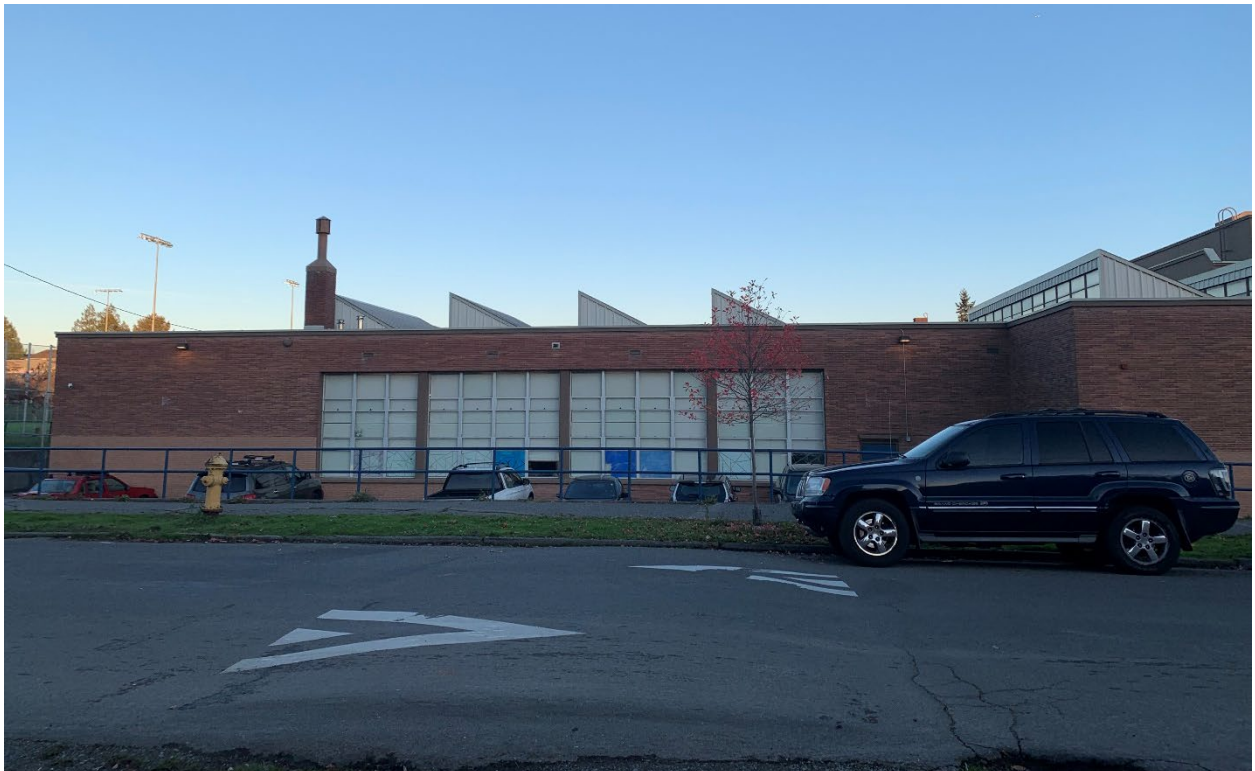
Photo 8

View of Project Site Facing East from Residence Located at 6115 39th Avenue S.

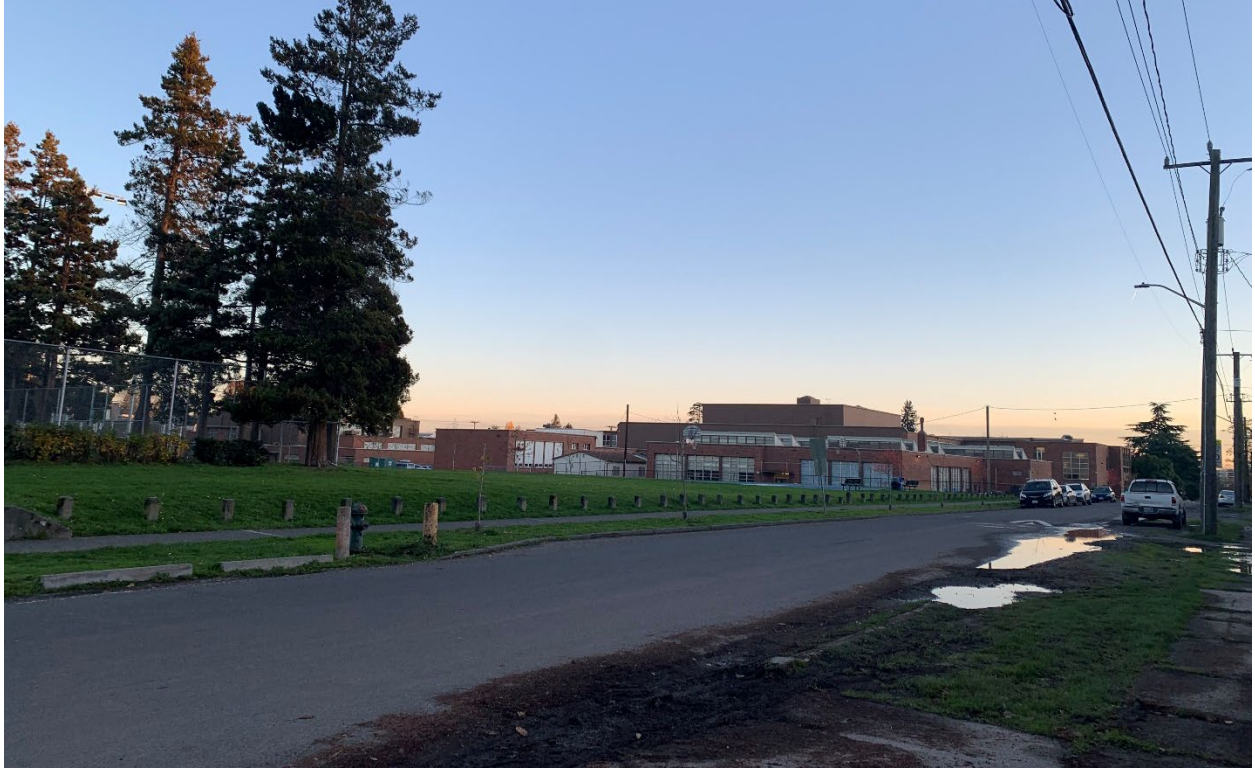
Photo 9

View of Project Site Facing Southeast from Residence Located at 5959 39th Avenue S.
