Facilities Condition Assessment

Final Report January 28, 2022

**Facility Condition Assessment
Learning Environment Assessment
Accessibility Evaluation
Final Report Rev1**

SÄZÄN
Environmental Services

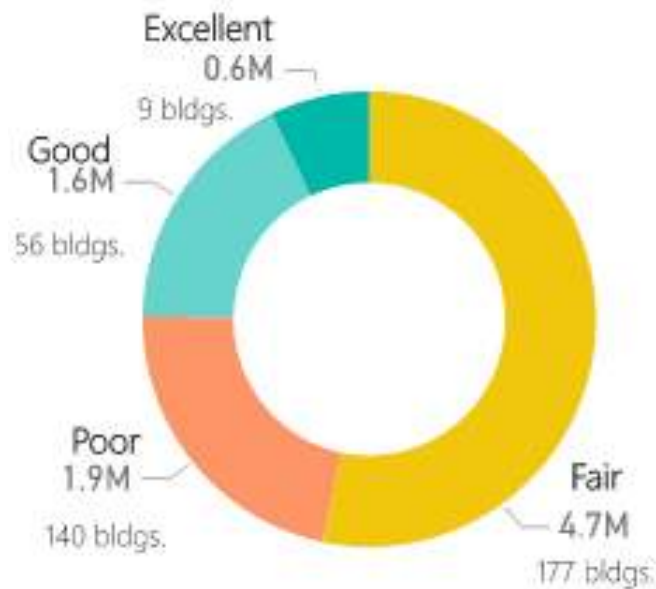
1.a 2021 Portfolio-wide Facility Weighted Average Condition Scores

Total Bldg. Portfolio Area (SF) by Weighted Average Condition Scores

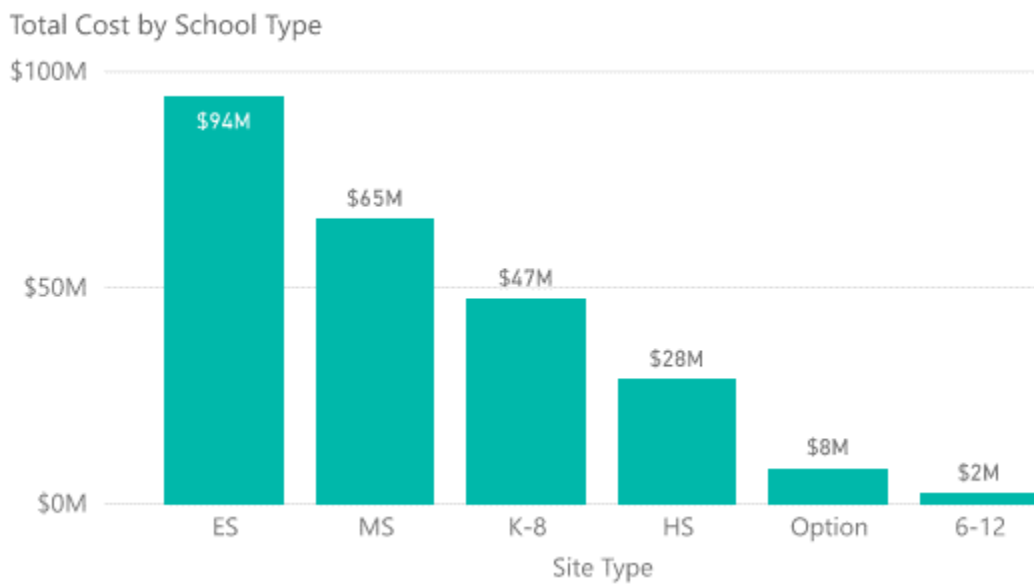
2.a Portfolio ODs by School Type

The large number of elementary schools contribute the most cost per type category.

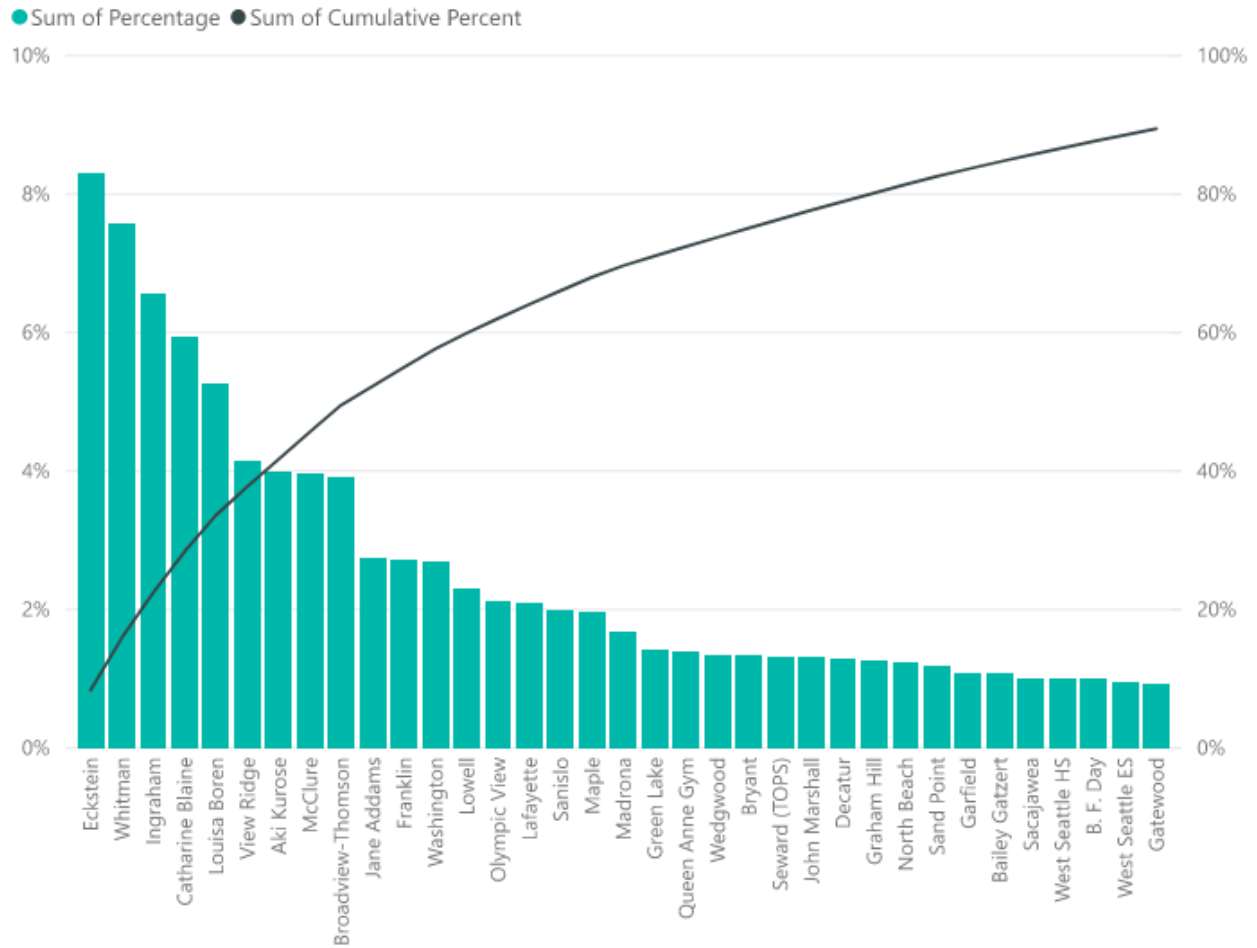
Pareto Analysis of Corrective Actions

The graph below and table on the following page are sorted by Observed Deficiency (OD) costs by site. The graphic below shows the top 85% of Corrective Actions, with the table beneath it calling out the top 30% contributors.

School	Sum of Direct Cost	Percentage
Eckstein	\$18,093,776	8.28%
Whitman	\$16,526,726	7.56%
Ingraham	\$14,297,153	6.54%
Catharine Blaine	\$12,930,933	5.91%
Louisa Boren	\$11,452,520	5.24%
Total	\$73,301,108	33.53%

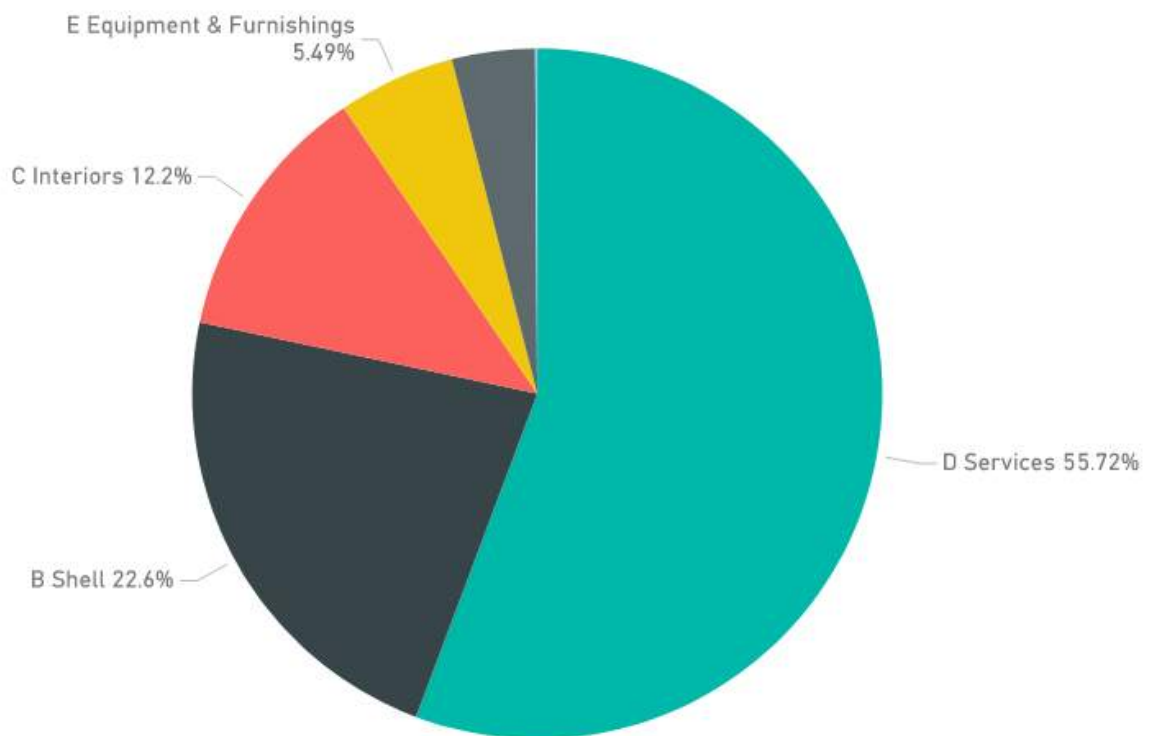
Total Cost by System

FCA data is organized by the CSI UniFormat standard categorization of building systems, consistent with OSPI reporting. This system defines and categorizes major building components into varying levels of detail, each with a unique code. A breakdown of Observed Deficiencies by Level 1 System is shown below. This analysis is broken down further into Level 2 Subsystems and Level 3 Components on the following pages. More information on subsystems can be found in Appendix A.

System	Direct Cost
D Services	\$136,319,117.77
B Shell	\$55,293,569.22
C Interiors	\$29,855,314.03
E Equipment & Furnishings	\$13,429,048.50
G Site Systems	\$9,514,092.00
A Substructure	\$238,600.00
Total	\$244,649,741.52

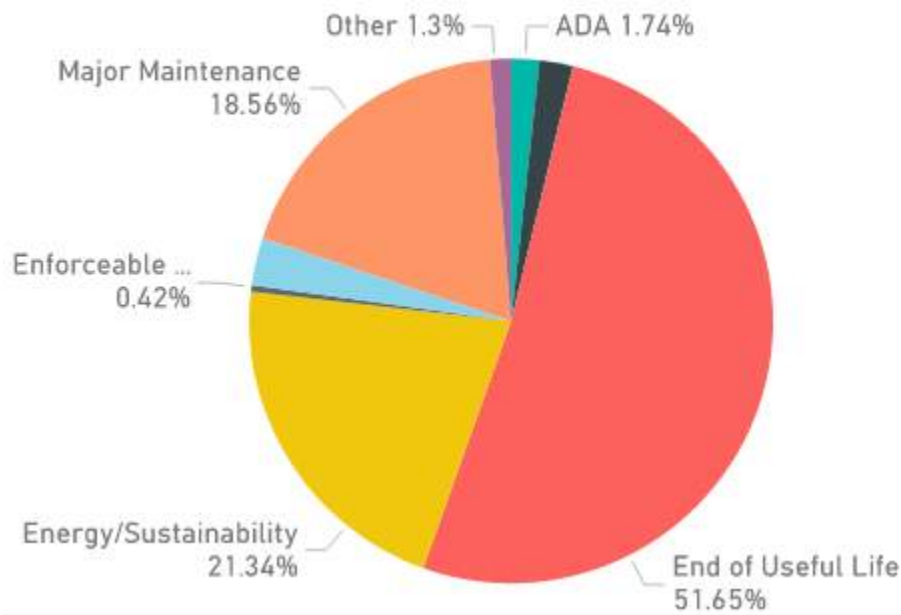
Total Cost by Action Type

It can be seen from the graphic below that 52% of immediate needs are associated with End of Useful Life, followed by Major Maintenance and Energy/Sustainability improvement opportunities.

Action Type	Direct Cost
End of Useful Life	\$126,367,006.78
Energy/Sustainability	\$52,201,150.52
Major Maintenance	\$45,416,389.20
Life Safety	\$7,169,002.72
Additional Evaluation Needed	\$5,033,377.15
ADA	\$4,255,539.10
Other	\$3,177,356.55
Enforceable Code Violation	\$1,029,919.50
Total	\$244,649,741.52

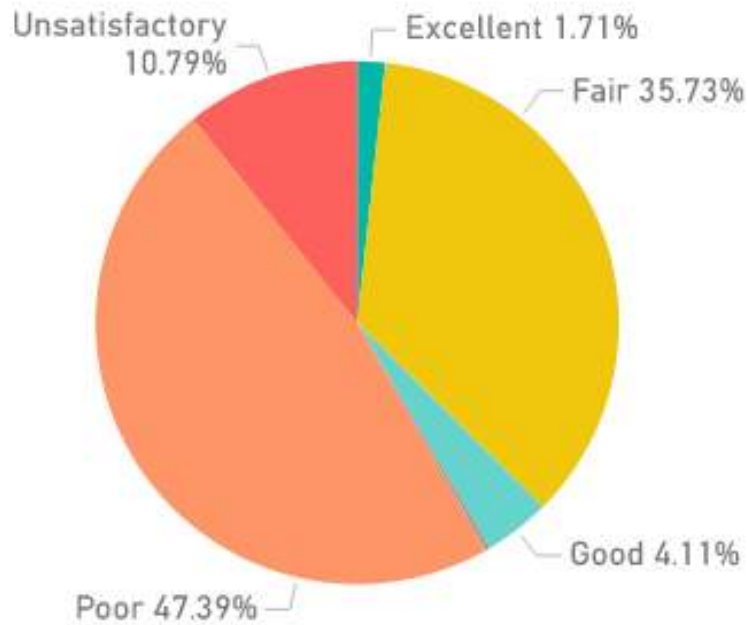
Total Cost by Condition Score

The chart below shows the scores compiled into dollar values. Components that are N/A do not currently exist but should, so no condition score was feasible for those components.

Condition Score	Direct Cost
N/A	\$660,769.50
Excellent	\$4,991,178.55
Good	\$10,047,931.25
Unsatisfactory	\$26,391,945.25
Fair	\$87,411,371.55
Poor	\$115,146,545.42
Total	\$244,649,741.52

Note that N/A refers to components that should exist but do not so no condition score could be assigned.

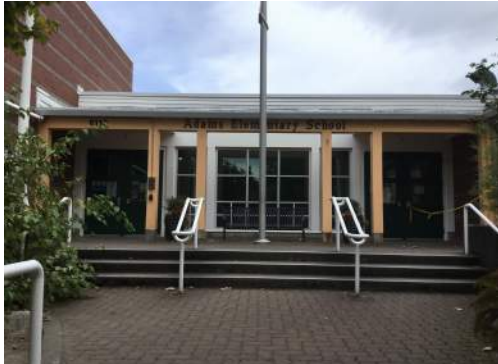
Adams
6110 28 AV NW SEATTLE, WA 98107

School Type	ES
No. Buildings	1
No. Portables	2
Total GSF	63,136
Year Built	1989
Year Modified	N/A

CSA - Adams ES is a single story elementary school with a basement. Overall, it is in fair condition. The building envelope needs attention: several areas on the roof are ponding; several window panes seals have failed.

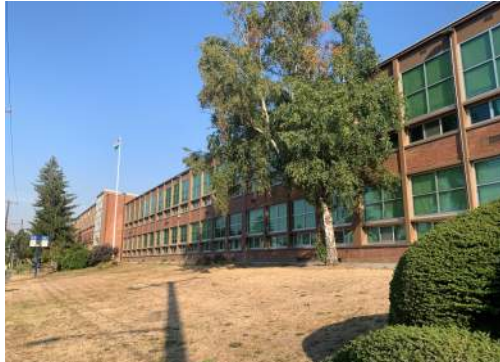
Aki Kurose
3928 S GRAHAM ST SEATTLE, WA 98118

School Type	MS
No. Buildings	1
No. Portables	2
Total GSF	171,393
Year Built	1952
Year Modified	N/A

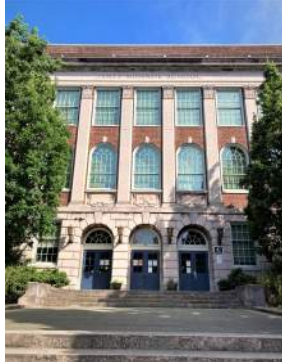
Monroe (Salmon Bay)
1810 NW 65th St SEATTLE, WA 98117

School Type	K-8
No. Buildings	1
No. Portables	0
Total GSF	117,116
Year Built	1930
Year Modified	1970

CSA - Most systems, interior and exterior finishes are past their useful life and should be repaired or replaced.

MEP - The facility is served by MEP systems that are long beyond their useful life. Most spaces have a steam radiator with an older pneumatic control valves and either damaged fiberglass or asbestos insulation. The radiators are in poor condition and should be refurbished. The exhaust fans (located one level below the roof) are original to the building with antiquated motors and deteriorated intake/discharge louvers (approx. 40) located on the roof. The large air handling units are 1915 vintage with obsolete belts and antiquated original motors and minimally functional controls. There are constant volume air handling units serving the library and cafeteria, which are in fair condition. The steam boilers have been replaced and are in fair condition, but are controlled by a Siemens Apogee system that is not supported by the manufacturer. The domestic hot water heaters and mixing valves have been replaced, but the piping in the building is a mixture of newer copper plumbing and galvanized steel. The MDF is served by an older R22 refrigerant A/C unit. Lighting and lighting control are T8's with switches that should be replaced with a more modern system.

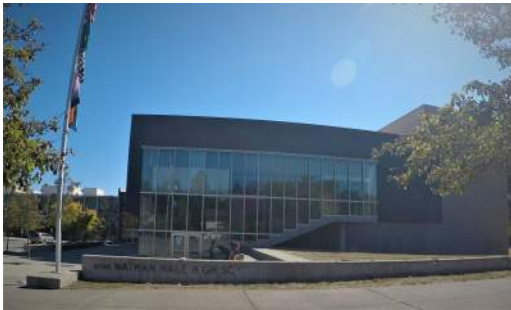
Nathan Hale
10750 30 AV NE SEATTLE, WA 98125

School Type	HS
No. Buildings	1
No. Portables	8
Total GSF	213,244
Year Built	1963
Year Modified	N/A

CSA - Overall, the school is in good condition and only needs preventative maintenance. Most issues are cleaning and maintenance upkeep. Carpets are in fair condition and the VCT is in good condition with the exception of some areas. Athletic flooring in the men’s locker room is coming apart and in disrepair, whereas the flooring in the girls locker room is in good condition. Resilient base throughout is worn. Walls are scuffed and require patch and paint. Most of the bathrooms have been remodeled to comply with ADA.

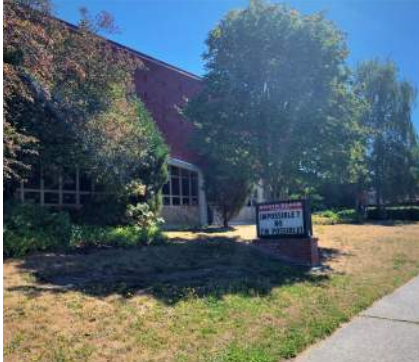
North Beach 9018 24 AV NW SEATTLE, WA 98117

School Type	ES
No. Buildings	1
No. Portables	12
Total GSF	37,439
Year Built	1957
Year Modified	N/A

CSA - The school is an older building that has been well maintained but is having issues due to age of building and equipment. The facility is past its useful life and needs replacement. Issues with storm drainage and erosion along the western edge of the property. Issues with water penetration between classroom wings and taller central structure. Doors are non-ADA compliant. Windows are single pane glazed. Trees are overgrown and allow climbers onto the building roof.

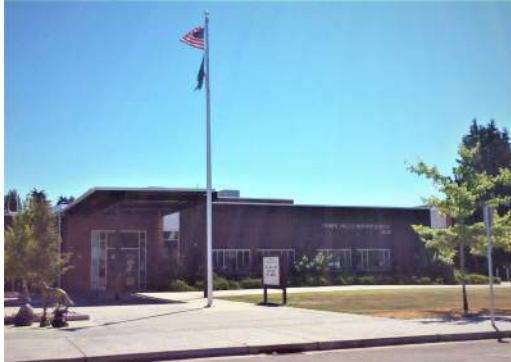
Olympic Hills
13018 20th Ave NE SEATTLE, WA 98125

School Type	ES
No. Buildings	1
No. Portables	0
Total GSF	96,081
Year Built	2018
Year Modified	N/A

CSA - The school overall is in excellent condition. Interior and exterior finishes are excellent, durable and well-maintained. The notable exception is that the resilient base corners have come off at about 40% or greater of locations, primarily in the corridors, but also other rooms. Noted 3 cases where the drywall corner was torn partially off.

MEP - The MEP systems at Olympic Hills appears to be in good condition. The HVAC system is a highly efficient geothermal water source heat pump system. The electrical is a standard 480/277 volt service with stepdown transformers for 208/120 volt. Data telecom equipment is in like new condition and appears to be in working order. All equipment appears to be in good condition. The fire alarm and fires sprinkler system testing appear to be out of date.

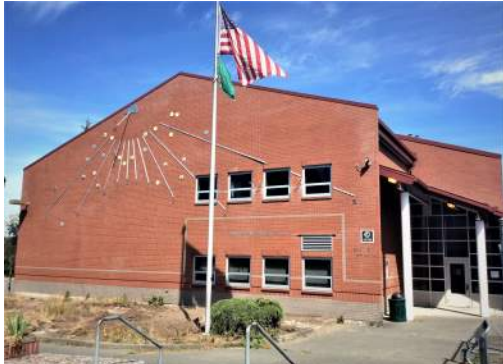
Olympic View
504 NE 95 ST SEATTLE, WA 98115

School Type	ES
No. Buildings	1
No. Portables	3
Total GSF	52,792
Year Built	1989
Year Modified	N/A

BCA Executive Summary	
<p>CSA - The school is older and the finishes are showing extensive wear. None of the classroom casework appears to be accessible. Many of the classroom walls have scuffs, dings, and torn drywall facing. School does not appear to be fully ADA compliant and a comprehensive ADA evaluation should be completed soon and improvements made. New finishes should be considered in the next 5 years.</p>	
<p>MEP - HVAC system/controls upgrade included newer heat pumps for heating and cooling installed in 2014 for classrooms. The boiler is original and in need of upgrades. Newer AO Smith hot water heaters installed 2017. Kitchen still original from 2008. Electrical system is at maximum capacity and should be upgraded.</p>

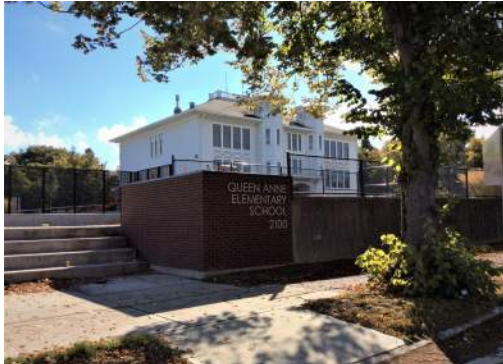
Queen Anne
411 Boston St. SEATTLE, WA 98109

School Type	ES
No. Buildings	2
No. Portables	0
Total GSF	65,661
Year Built	1903
Year Modified	2012

CSA - The new addition and associated sitework is in excellent to good condition. The older 1922 and 1903 buildings are sound, but have worn surface conditions, with historic character. Older buildings are likely not well insulated. The windows are single pane, though they are wood and have spring metal seals. The 1903 building has some damage to the exterior stucco in a few locations that warrant repair. Site is in good condition overall.

Does the means of egress appear deficient?
Egress at the 1903 building is challenging due to the basement ramp access. The ramp is relatively narrow and has a corner turner to access the entry door.

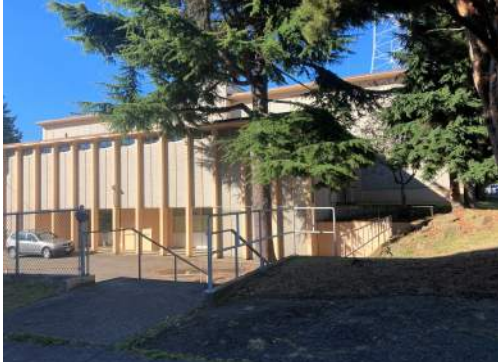
Queen Anne Gym
1431 2nd Ave N SEATTLE, WA 98109

School Type	Option
No. Buildings	1
No. Portables	0
Total GSF	35,805
Year Built	1961
Year Modified	N/A

CSA - Many of the facility systems and components are past their useful life. Interagency has interim spaces developed and maintained for the current limited use. These spaces include several classrooms, lounging area, and the gym. The back basement (former shower/locker/office areas) of the building is derelict with exposed bolts from the slab creating trip hazards. This area is "off-limits" and not maintained.

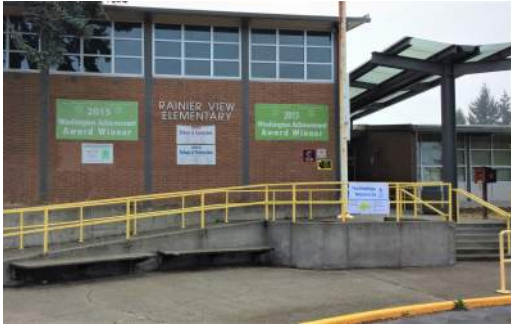
Rainier View
11650 BEACON AV S SEATTLE, WA 98178

School Type	ES
No. Buildings	1
No. Portables	6
Total GSF	38,141
Year Built	1961
Year Modified	N/A

MEP - The building is generally heated using fin tube radiators. A single air handling unit provides outside air to all the interior classroom and office spaces. The outside air fan is quite old and dirty and is manually turned on and off each day by the custodian. It appears that the VFD and controls may have failed. Replacement of the outside air handling unit is recommended. The lighting appears to have been updated within the last 10 years. The electrical distribution systems also appear newer. Access controls are not provide, but the security alarm system appears to be functioning along with the fire alarm.

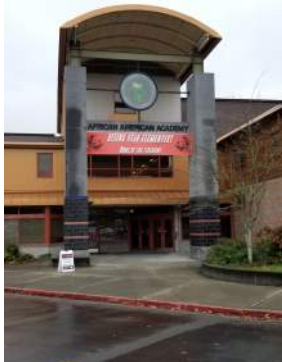
Rising Star
8311 BEACON AV S SEATTLE, WA 98108

School Type	ES
No. Buildings	1
No. Portables	0
Total GSF	106,370
Year Built	2000
Year Modified	N/A

CSA - At the time of this assessment, the building was under construction in some areas, dealing with past roofing issues. Generally, the exterior of building appears sound with no visible defects. The interiors are in decent condition, but beginning to show their age with normal wear and tear. Some overgrowth around site, but generally in good condition.

MEP - The HVAC system is a four pipe air handling system with water cooled chillers and a cooling tower to make chilled water. Gas fired cast iron boilers generate hot water. The Assistant Principal indicated there are some slightly hot rooms. It is suggested the building should be recommissioned to find incorrect issues related to temperature control. The lighting is generally fluorescent and appear to be in operating condition.

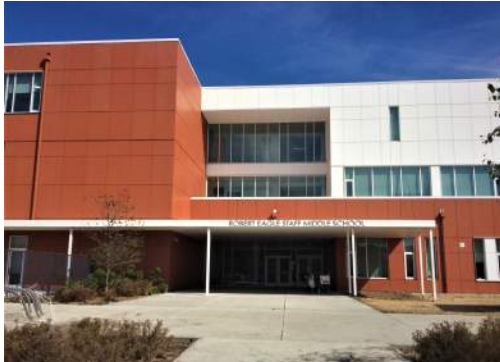
Robert Eagle Staff
1330 N 90th St SEATTLE, WA 98103

School Type	MS
No. Buildings	1
No. Portables	7
Total GSF	160,419
Year Built	2015
Year Modified	N/A

BCA Executive Summary	
<p>CSA - This school is less than 3 years old and is in excellent condition, with some minor exceptions (e.g., painted walls and a few of the orange acoustical panels). Otherwise the finishes are in excellent condition. Virtually every room has paint damage where masking tape peeled the paint off down to the face of the gypsum board. This may be an indication that the primer was not dry or was not applied before the finish coats were applied. In addition, there are several acoustical panels that have torn edges.</p> <p>The facilities maintenance staff shared there is a bank of light fixtures in room 255 that do not work correctly and a fuse in a nearby panel that is blown.</p>	
<p>MEP - HVAC is excellent condition and well maintained . Strategically placed mechanical rooms house blower coils feeding individual classrooms with a condensing loop from onsite HPs for heating and cooling. The fire sprinkler system and domestic water are new condition. Plumbing fixtures new energy efficient type installed new in 2017.</p>

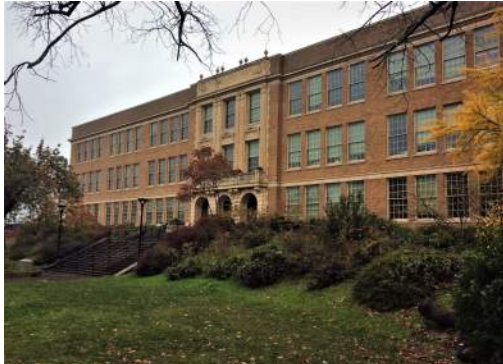
Roosevelt 401 NE Northgate Way SEATTLE, WA 98125
--

School Type	HS
No. Buildings	1
No. Portables	6
Total GSF	298,534
Year Built	1922
Year Modified	2006

CSA - Overall, Roosevelt HS is in good condition with just a few significant issues. The primary consideration is the condition of the VCT flooring, which appears to have either a defective material or application issue. Approximately, 60% of the VCT floor has a darker shade finish that is obscuring the VCT tile colors and is wearing unevenly with blotches and scrapes showing through. The interior windows (i.e., door relites) in corridors and similar locations have wire glass, but are otherwise in good condition. ADA requirements are well met, if not exceptional compared to other SPS schools. The structure appears to be solid, with minor cracking observed in the foundation. A crack in the slab is appearing on the second floor of the 2006 addition in the northeast corner, which should be monitored. The thermal envelope appears to have been fully upgraded during the 2006 renovation. The facility is wearing well and is being well cared for by the occupants and facilities staff.

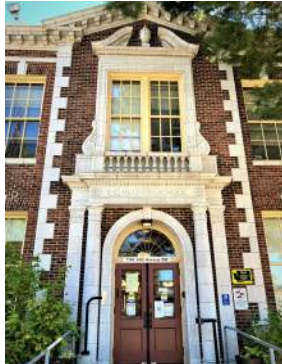
Roxhill at E.C. Hughes
7740 34th Ave SW SEATTLE, WA 98126

School Type	ES
No. Buildings	1
No. Portables	9
Total GSF	48,010
Year Built	1926
Year Modified	2018

BCA Executive Summary	
CSA - Roxhill Elementary program is now operating in the newly renovated, and historically landmarked, E.C. Hughes ES facility. Completed in 2018, E.C. Hughes is in good condition with a blend of modern and original, but still struggles with accessibility to some spaces and single pane glazing through much of the building.	
MEP - E.C. Hughes mechanical system is generally radiators with dedicated outside air system. The building appears to have been recently upgraded and renovated. Lighting appears to be in like new condition along with security, access control, fire alarm, fire sprinkler, electrical distribution and HVAC systems.

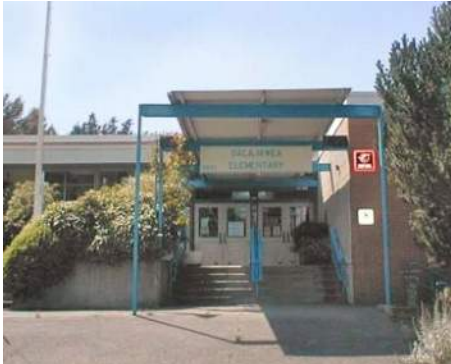
Sacajawea
9501 20 AV NE SEATTLE, WA 98115

School Type	ES
No. Buildings	1
No. Portables	5
Total GSF	38,957
Year Built	1959
Year Modified	N/A

BCA Executive Summary	
<p>CSA - Overall, the condition of Sacagawea "poor" and the facility is due for replacement since it is outdated and deteriorating quickly. Although there have been some major upgrades in the past, (i.e. seismic bracing, limited ADA upgrade to bathrooms, various cosmetic improvements, etc.) there remain many deficiencies that will require high-dollar corrections. ADA upgrades are likely upwards of \$1.5 million alone, and some issues may not be able to be corrected. Energy efficiency upgrades (e.g., windows, doors, skylight openings) are also likely to cost millions.</p>	
<p>MEP - The HVAC system consists of newer Cleaver Brooks boilers and circulation pumps. However, the AHUs and ventilation are of original vintage and in need of upgrading to new high energy efficient type. Controls upgrades were completed back in early 2010s, however only some of the control valves for heating have been replaced and represent a combination of Siemens Apogee DDC with old pneumatic control valves. Lighting is a combination of incandescent, fluorescent and some LED bulbs in common spaces. Plumbing fixtures and sinks are old and deteriorated.</p>

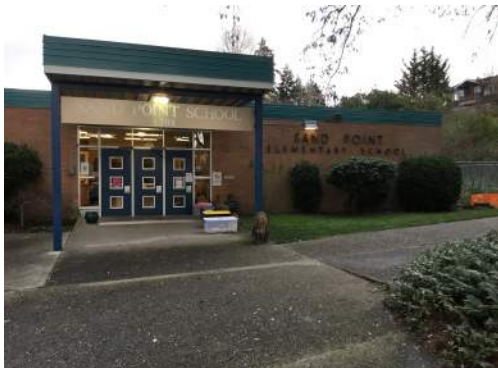
Sand Point
6208 60 Ave NE SEATTLE, WA 98115

School Type	ES
No. Buildings	1
No. Portables	7
Total GSF	33,899
Year Built	1957
Year Modified	N/A

BCA Executive Summary	
<p>CSA - Sand Point is a late 1950s vintage, single story building, although appears to have had some seismic upgrade work. Exterior windows are single pane throughout. Some exterior doors (to covered play) are wood, hardware is old and will need replacement. The roof has been a long-term problem with visible cracks, bare areas and multiple soft spots. This should be addressed as a priority for preservation of the building.</p>	
<p>MEP - Newer benchmark condensing boilers, VRF driven hot water distribution pumps with Johnson Controls DDC upgrades were installed less than 8-9 years ago. Recent domestic hot water heaters were also upgraded and appear in good condition. Some major electrical upgrades in boiler room and lighting to classrooms are also apparent. However, security and public address/clock system could use upgrades. Fire suppression/protection is in good condition.</p>

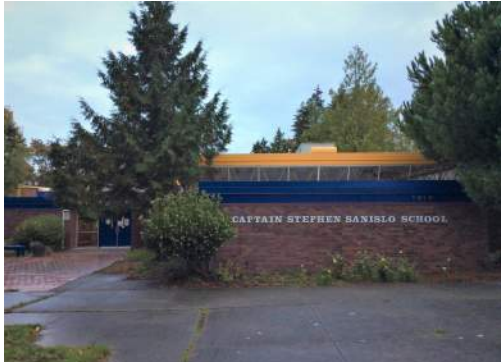
Sanislo 1812 SW MYRTLE ST SEATTLE, WA 98106

School Type	ES
No. Buildings	1
No. Portables	3
Total GSF	40,574
Year Built	1972
Year Modified	1998

CSA - Sanislo ES has served beyond it's useful life. The building has major structural issues, water intrusion problems, ADA non-compliance, and a severely inadequate thermal envelope. Cost for remediating the issues far outweighs the cost of replacement.

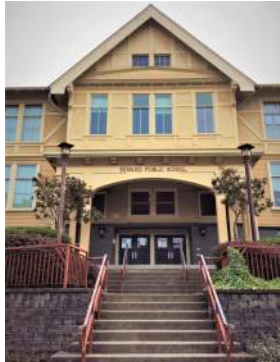
Seward (TOPS)
2500 FRANKLIN AV E SEATTLE, WA 98102

School Type	K-8
No. Buildings	4
No. Portables	0
Total GSF	95,501
Year Built	1895
Year Modified	1999

BCA Executive Summary	
CSA - Seward is nicely maintained but the exterior is in need of major maintenance and interior finishes are worn, particularly in the older buildings and at the end of their useful life.	
MEP - The school is comprised of four buildings, built at various times over the years, with the Library structure built to unify all building additions. The HVAC system is a four pipe air handling system with a chiller and boilers providing chilled and hot water. The system was noted to have difficulties maintaining temperature through out the building. The lighting in the each of the building is in good condition. Electrical distribution is standard 480 volt service with distributed 208 volt transformers. It is strongly recommended to recommissioning the HVAC system to address temperature control issues.

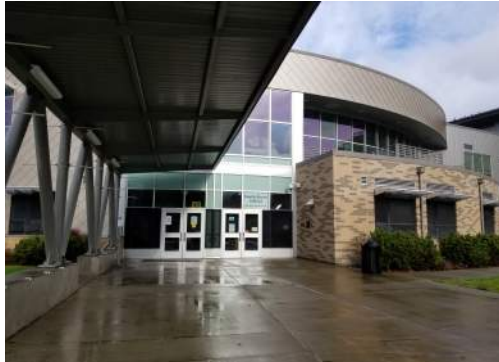
South Shore
4800 S Henderson St SEATTLE, WA 98118

School Type	K-8
No. Buildings	2
No. Portables	0
Total GSF	241,501
Year Built	2009
Year Modified	N/A

CSA - The school is generally in good shape and wearing very well for being now 10 years old. The exterior envelope materials are in very good shape. The childcare area has some cracking of the slab that is telegraphing through the VCT, but this condition appears to be limited to this area. Roofing is in good condition, however needs routine maintenance: moss cleaning. The pairs of corridor doors at the entrances of the classroom wings and at the stairwells need adjustment of the panic bars to ensure that they latch properly. Two panic bars at a stairwell location are pulling loose from the door and need to be reattached. Several of the exterior hollow metal frame doors and frames are sticking and do not close properly. Walls and carpeting have the typical signs of wear, particularly at the upper two floors (and upper grade levels). The fields and landscaping are suffering from lack of maintenance and watering.

MEP - The HVAC is generally a hydronic 4-pipe system with fan coil units. Boilers and a chiller provide the heating and chilled water. The electrical distribution system is a standard 480 volt with distributed 208 volt transformers. The building has an emergency generator. Fire alarm security access controls all appear in good condition and operable. The only major issues we found was it appears that the heating water hose kits at the fan coil units appear to be failing at approximately 50% of the units.

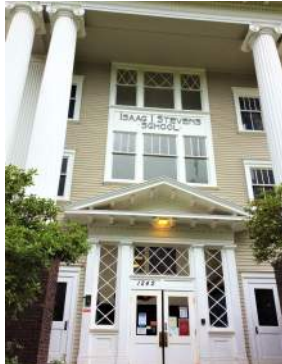
Stevens
1242 18 AV E SEATTLE, WA 98112

School Type	ES
No. Buildings	4
No. Portables	0
Total GSF	72,289
Year Built	1906
Year Modified	2001

CSA - The campus buildings are in reasonably good shape and well maintained. There are some areas showing wear, such as the older carpet and wood flooring that are now showing their age. The primary concern is lack of good weather seals on the doors and some of the windows. The other significant energy efficiency issue is that the roof for the older building does not appear to be insulated.

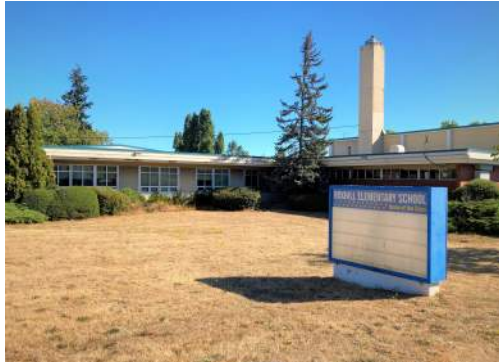
SW Interagency Academy at Roxhill
7740 34th Ave SW SEATTLE, WA 98126

School Type	Option
No. Buildings	1
No. Portables	4
Total GSF	42,102
Year Built	1957
Year Modified	N/A

BCA Executive Summary	
CSA - Although this facility's structure appears sound and some areas of the building and site have been updated; new windows, finishes and certain equipment, overall the facility is at the end of its normal useful life.	
MEP - The HVAC system is beyond normal useful life. The lighting is mostly fluorescent and in poor condition. The security system is marginal, although the fire alarm and sprinkler systems appear to be operational and in good condition.

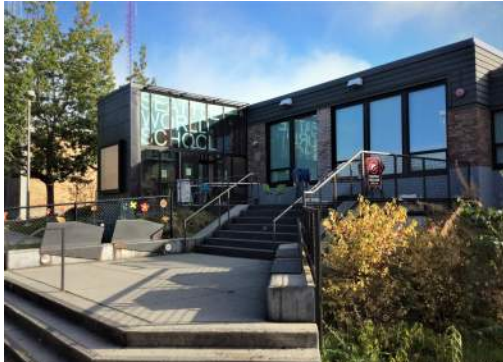
T.T. Minor (Seattle World School)
1700 E UNION ST SEATTLE, WA 98122

School Type	6-12
No. Buildings	2
No. Portables	0
Total GSF	59,495
Year Built	1940
Year Modified	2016

CSA - Overall, the 2014 renovation of the main building is in good condition with some exceptions. The red vinyl flooring is bubbling in a couple locations and poses a tripping hazard. The flooring may not have been properly adhered, or potentially there is a moisture problem in the area of bubbling. The roof insulation was not properly tapered and there is standing water in multiple locations on the main building and at the gym roofs. The gym is old and notwithstanding new clerestory units, needs either a major renovation or total replacement (i.e., severely undersized). The Principal shared a number of operational issues: stage lighting only illuminates the front edge of the stage, which requires secondary lighting to illuminate the balance of the stage. There is a large number of restrooms in the admin, lobby, resource and cafeteria end of the building, however insufficient number of restrooms in the classroom wings where needed. There is no ADA staff restroom on the second floor.
