Aki Kurose Middle School Addition and Modernization Project

Final Project SEPA Checklist

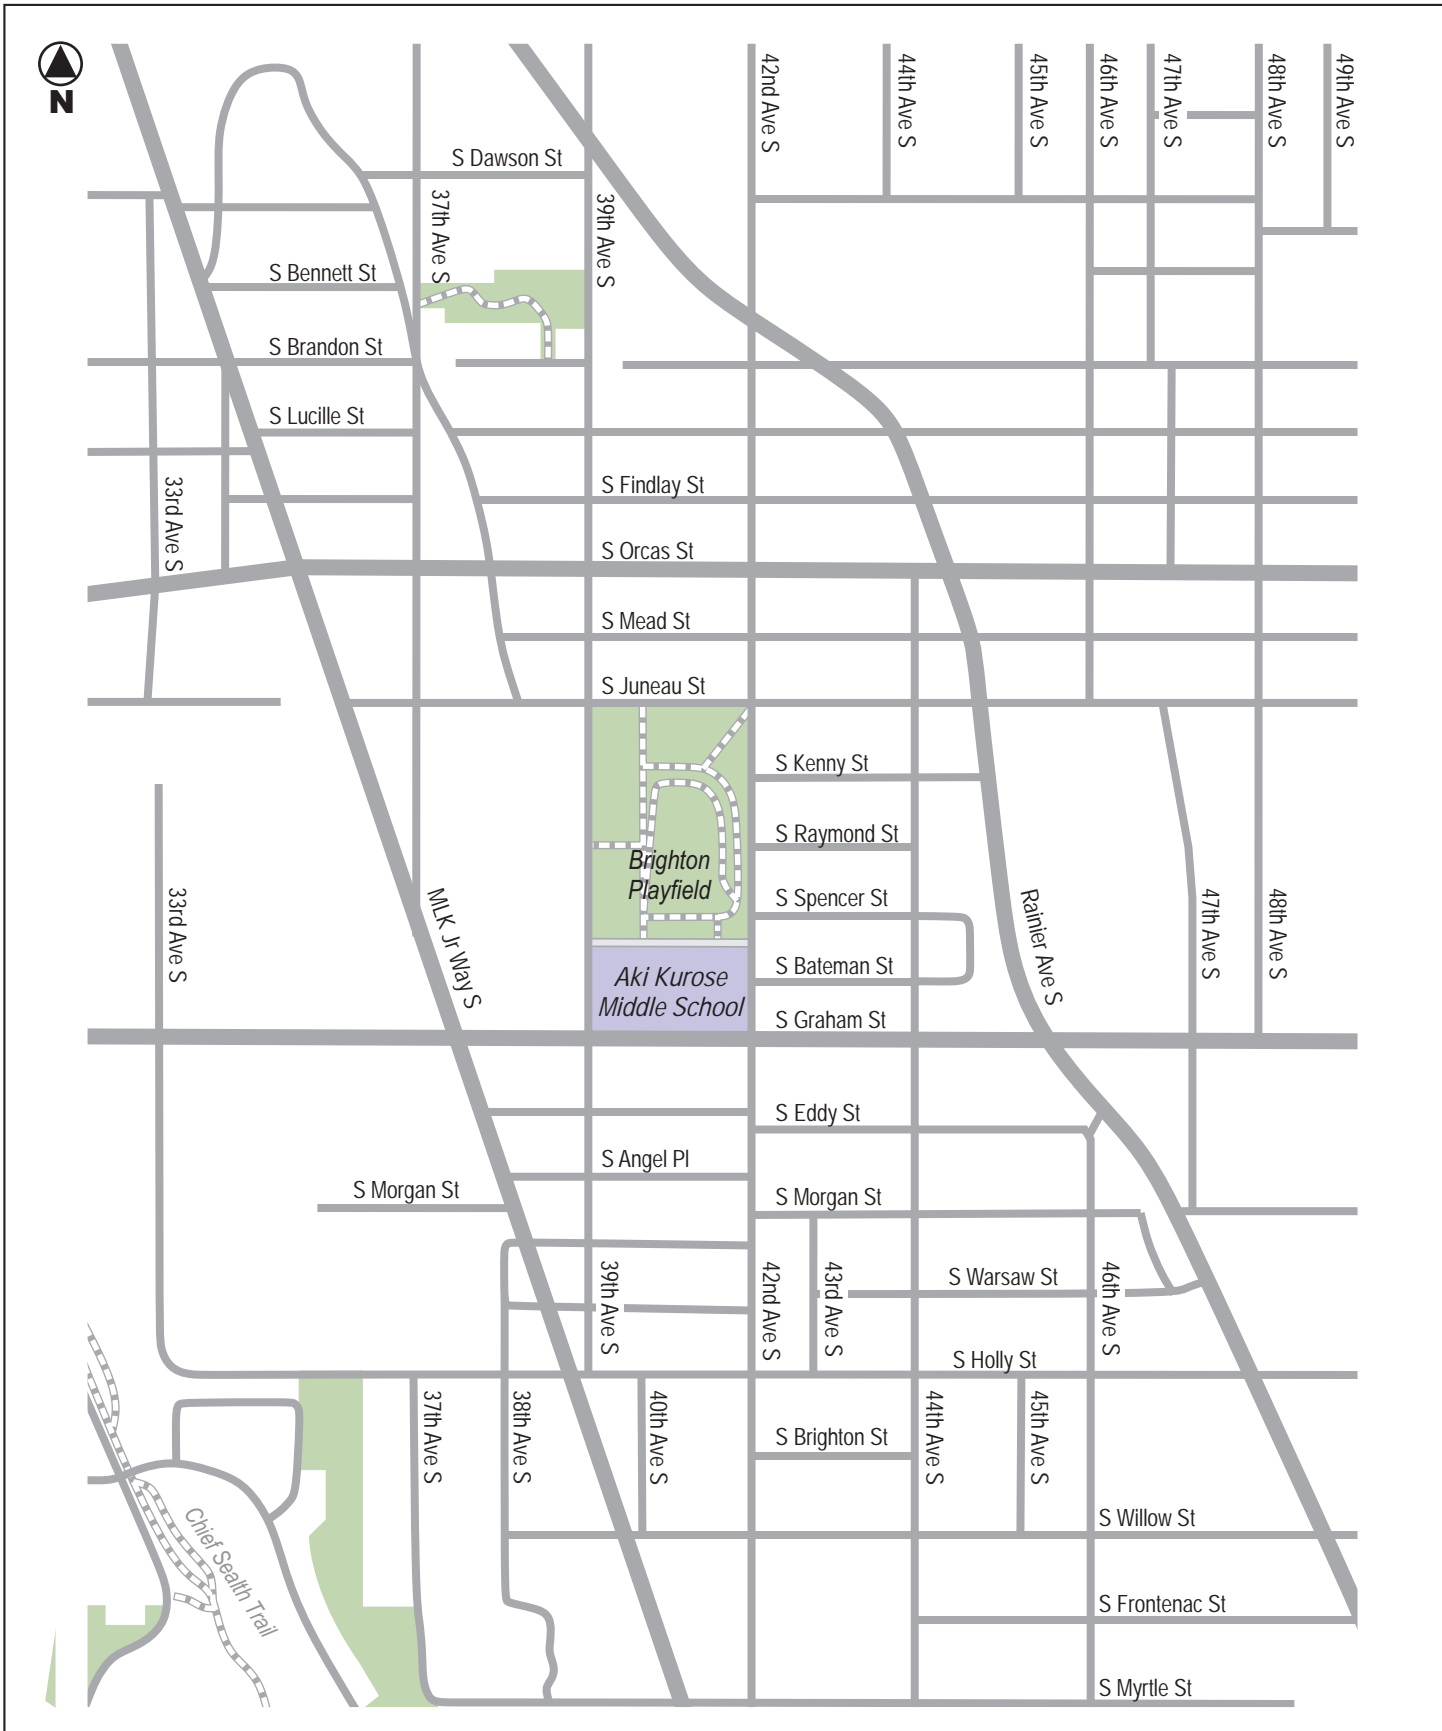
Figure 2
Project Site and Vicinity

**AKI KUROSE MIDDLE SCHOOL
Renovation and Addition**

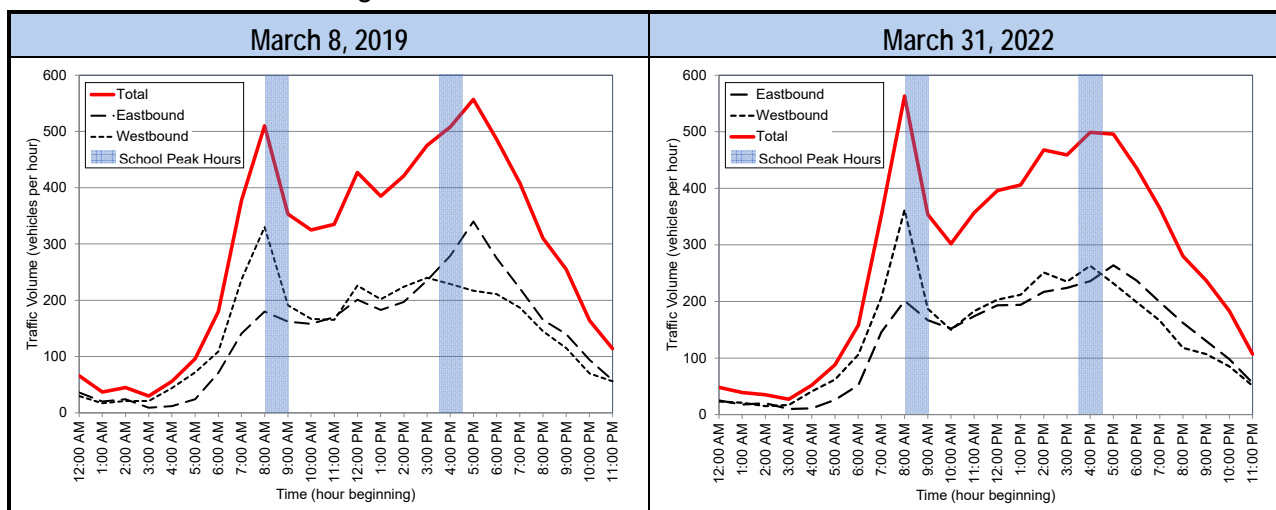
Figure 3. Traffic Volumes on S Graham Street

Source: Idax Data Solutions, March 8, 2019 and March 31, 2022.

Data from the S Graham Street / Rainier Avenue S intersection published in the traffic analysis for the *6211 Rainier Ave S Townhomes*¹⁷ project indicate morning peak hour volumes there have declined by over 4% per year. A comparison of average weekday hourly data from two seven-day machine counts on S Graham Street between 39th and 42nd Avenue S (collected by Idax in March 2019 and March 2022) found overall declines of about 1% per year, but increases in morning peak hour volumes (by about 3% per year) and declines in afternoon volumes (by about 1% per year). Figure 3 shows the average hourly volumes from both counts.

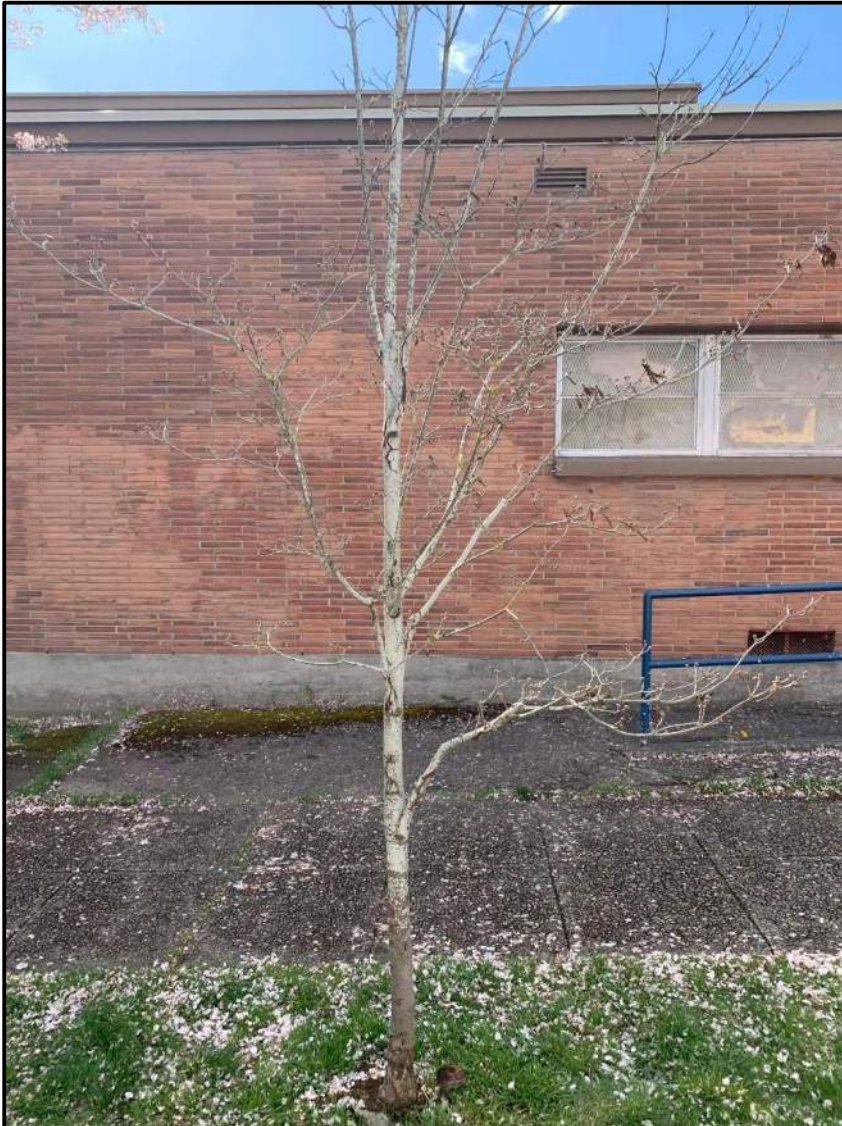
Photo 1. SDOT ROW tree TRE-1055664 that has died from string mower damage at the base. Other newly planted trees show similar damage but have not died. (April 2023)

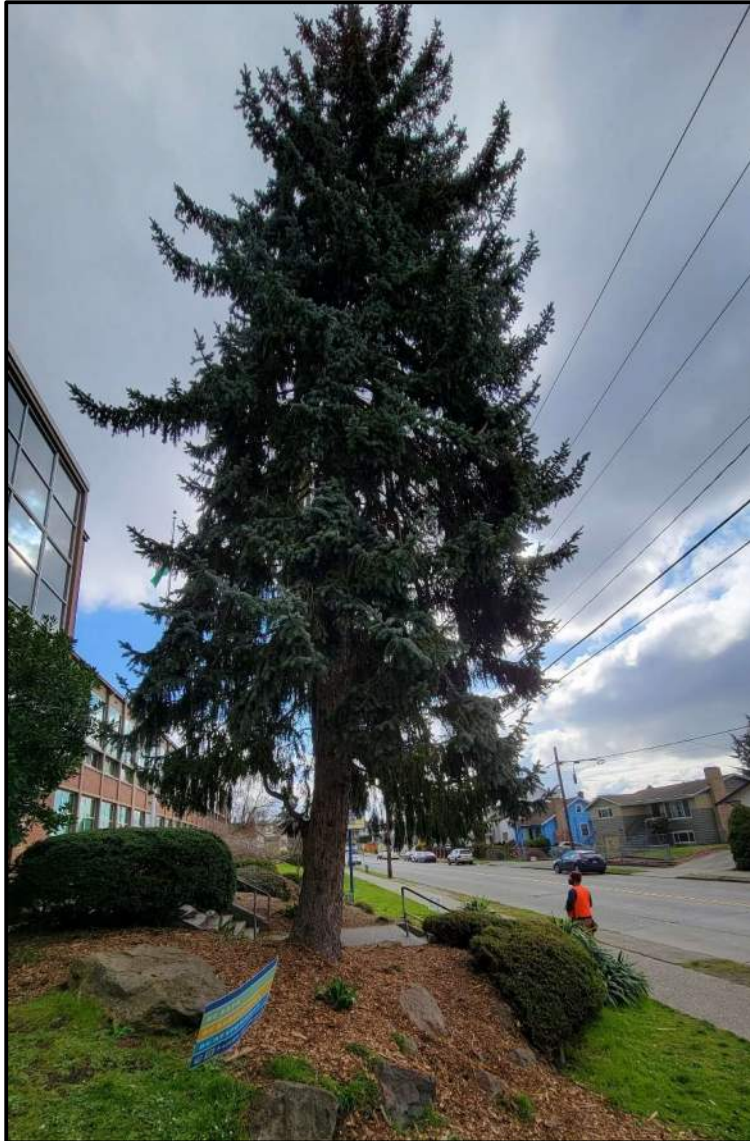
Photo 2. Tree 179 growing in a rockery and adjacent to the main stairway. The tree's roots are likely intertwined with the rockery and should be taken into consideration when designing and installing the new school entrance. (April 2023)

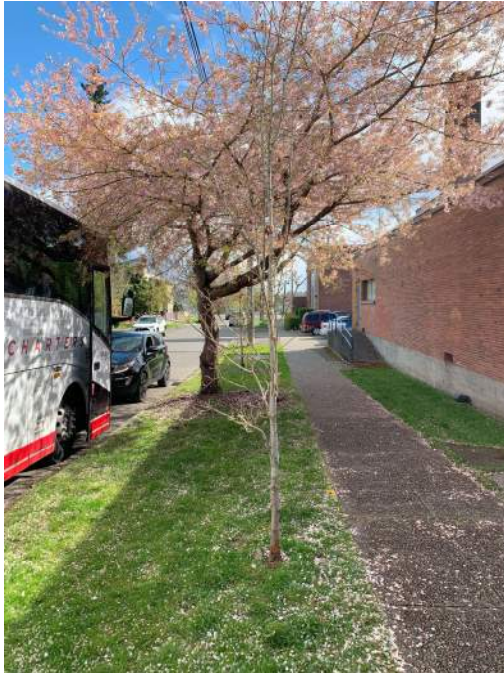
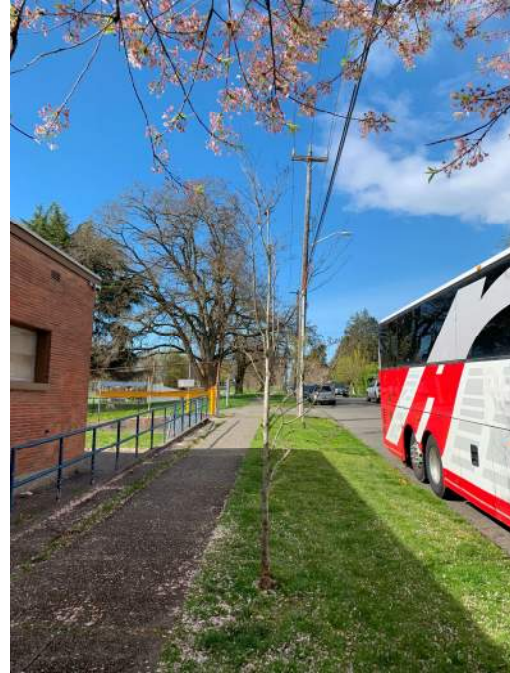
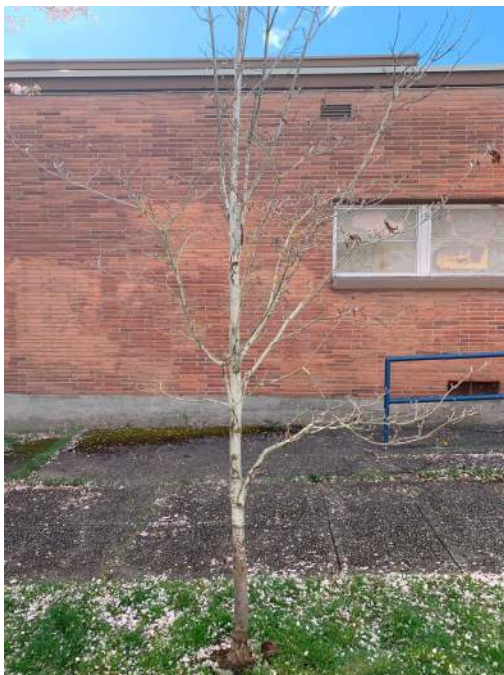
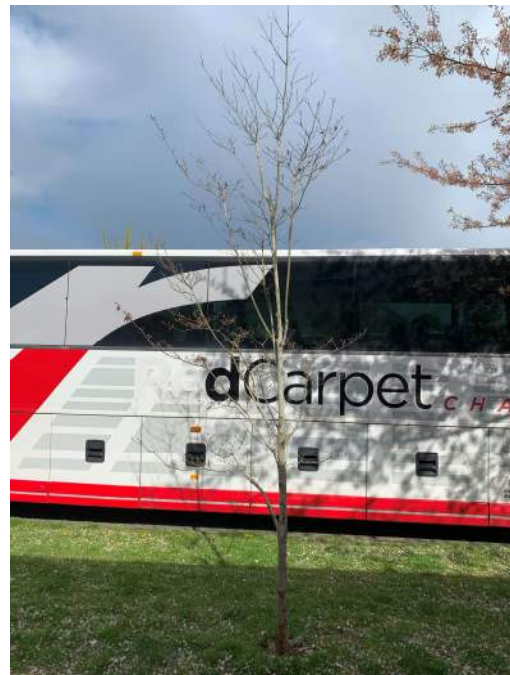
ROW TRE-1055664: Tree is Dead and will not fully foliate.

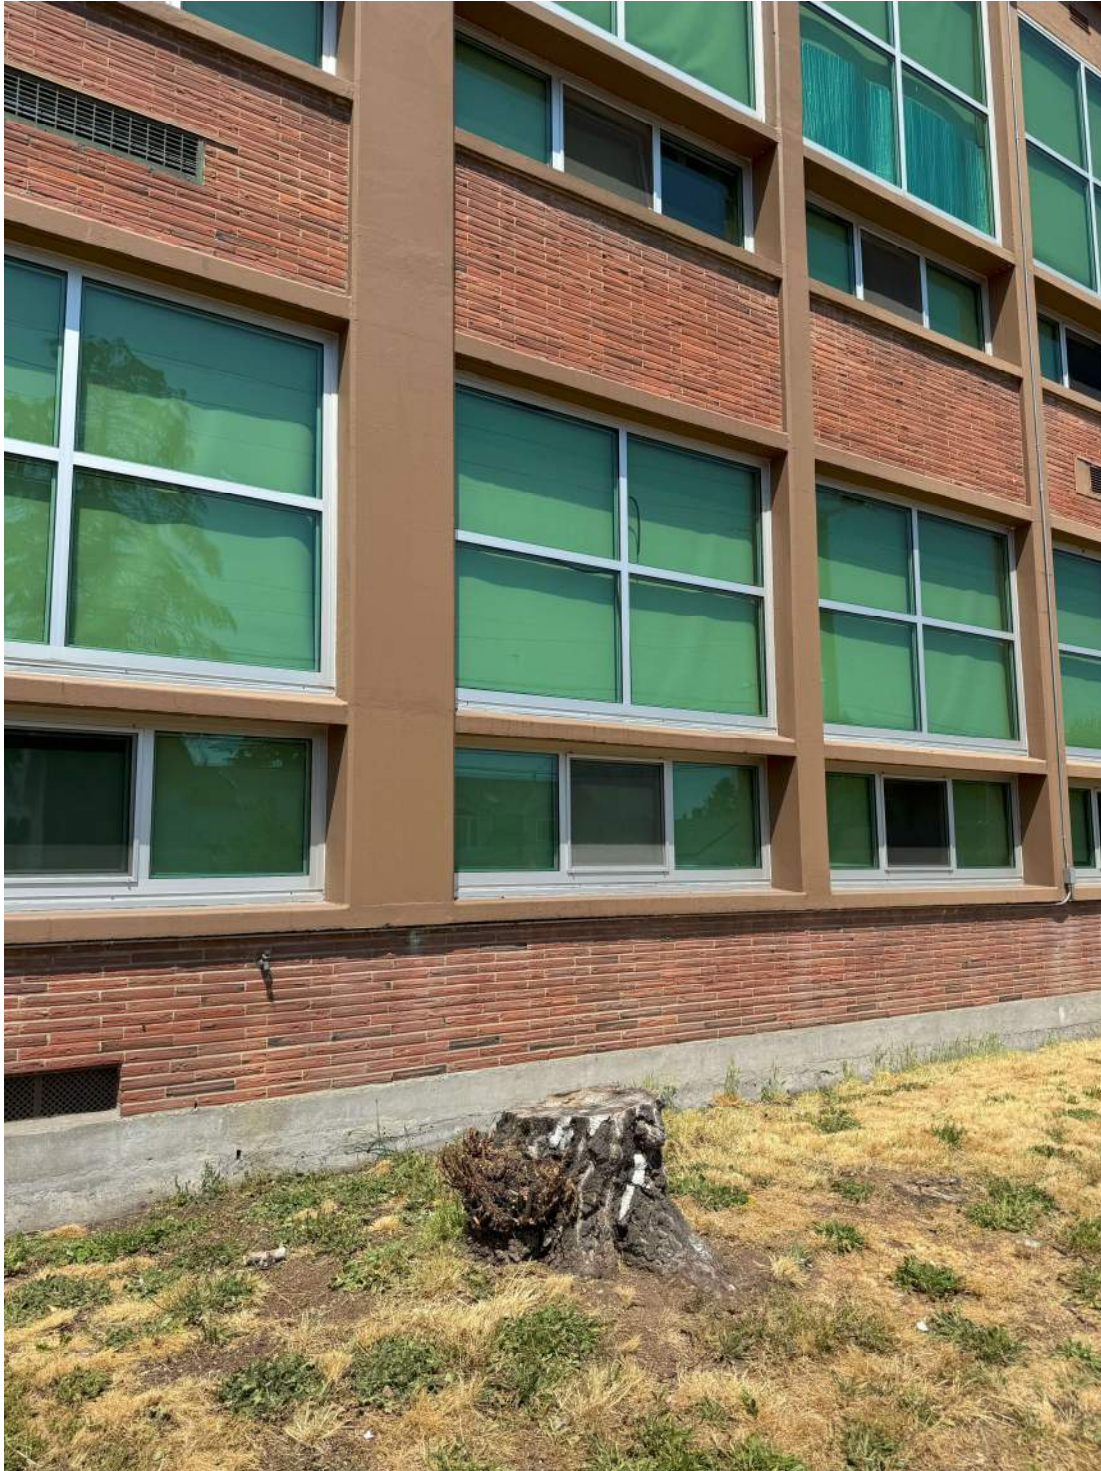
Tree 181:

July 11, 2024 – Tree 181 has been removed.

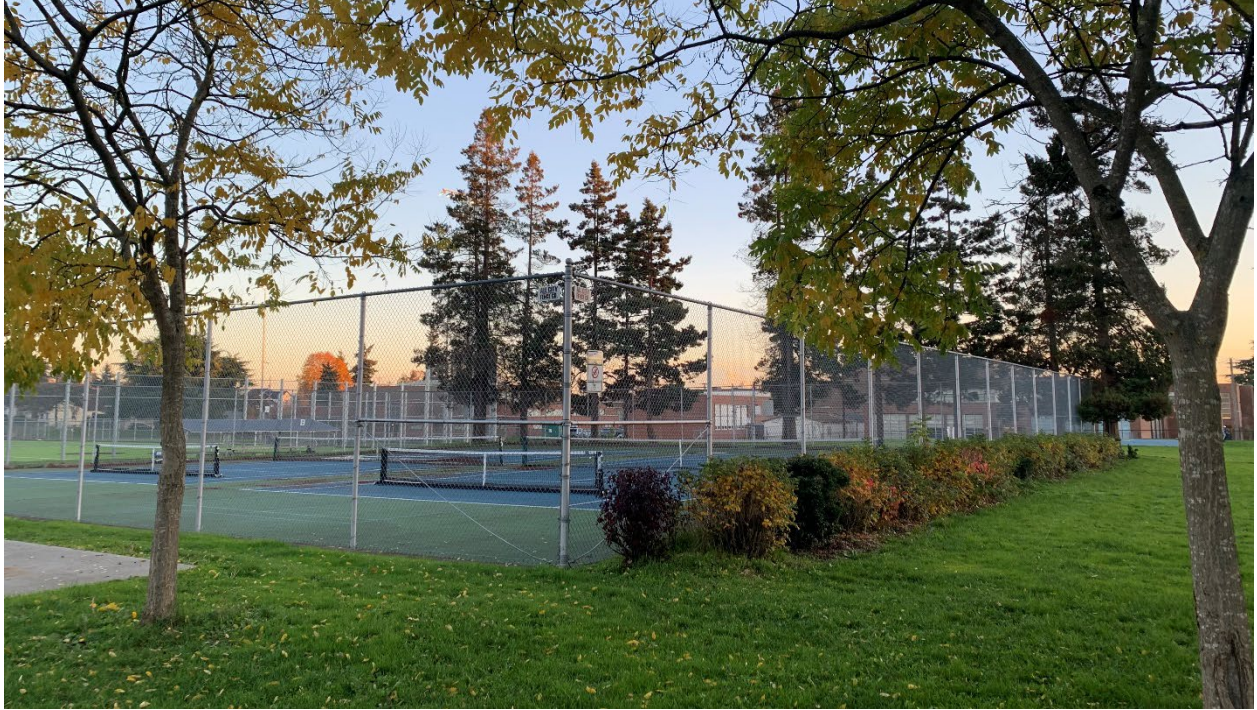
Photo 1

View of Project Site Facing Southeast from Brighton Playfield Located at 6000 39th Avenue S. Mount Rainier is visible in the gap between trees. This view would potentially be obscured by the proposed two-story addition; however, the existing view is already partially obstructed by fencing.

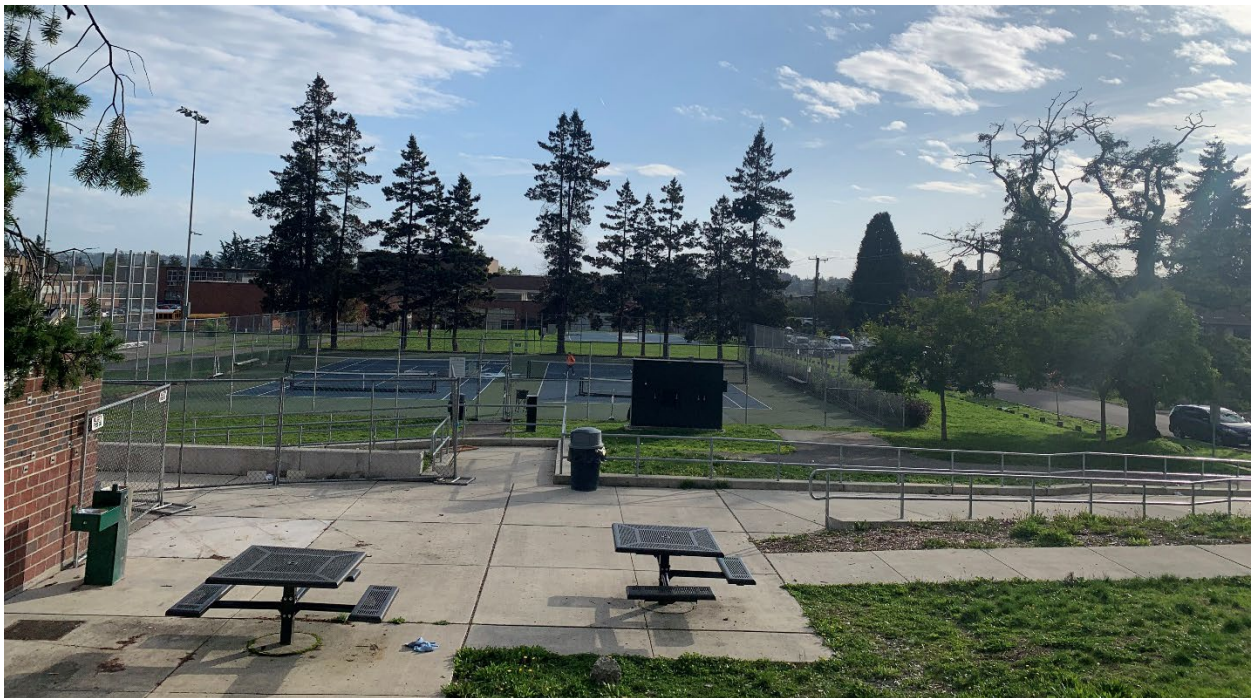
Photo 2

View of Project Site Facing South from Brighton Playfield Located at 6000 39th Avenue S. The school is partially obscured by trees, and no views of the mountains would be obstructed.

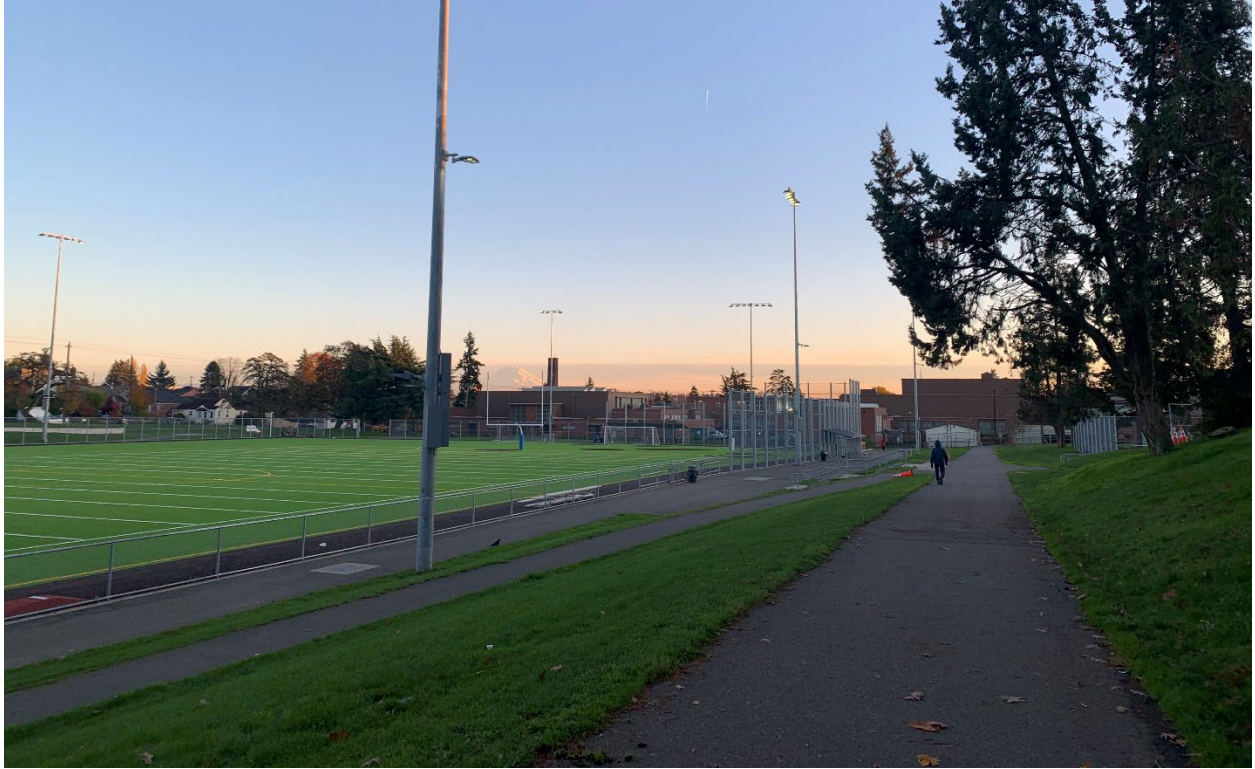
Photo 3

View of Project Site Facing South from Brighton Playfield Located at 6000 39th Avenue South. Mount Rainier is visible between the football goalposts. The chimney on the east side of the school building will be removed, enhancing views of Mount Rainier from the playfield.
